**Special Planning Commission Meeting
Tuesday, June 09, 2020
7 PM, Via Teleconference or Other Electronic Means**

6a. Public Hearing to discuss CUP #20-05 for fill in excess of 100 Cubic yards: 7 Eagle Ridge Road

Re: 7 Eagle Ridge Road Erosion Repair

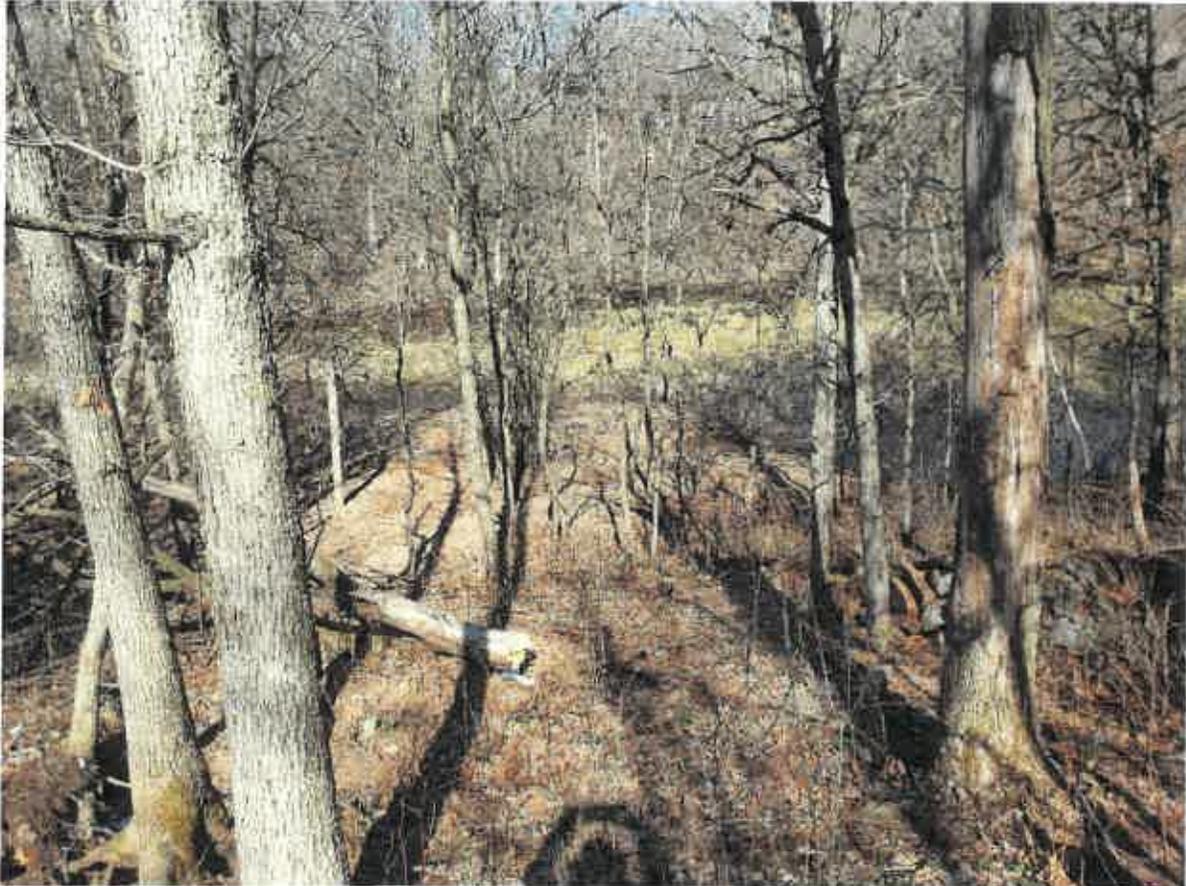
Photo

Previous calculations indicate approximately 500 cubic yards of material washed down the 4H:1V slope and deposited into and upstream of a PEM1C wetland at the base of the slope. This material is available to be excavated under a WCA No-Loss decision by the Vadnais Lake Area Water Management Organization (VLAWMO). Care will be taken when excavating to avoid removing any of the underlying wetland vegetation or soils. It is anticipated that less than 100 cubic yards is able to be safely removed. Several small trees at the edge of the wetland, now partially buried by sediment, are invasive species and can be removed with the excavation (See Photo1), but removal will be limited to maintain stabilization of the area.

1 – Delta of material washed into the wetland (Pinnacle, 4-17-2020)

Other soils used for backfill will be sourced to meet the specifications attached (Exhibit 2), including a SP or SP-SM material and 4 inches of topsoil for backfilling the gully. Results of geotechnical testing of the site soils are included in Exhibit 3. The disturbed area will be covered with 4 inches of topsoil in accordance with specifications in Exhibit 2. Plantings, seeding, and erosion protection will be completed as soon as topsoil placement and fine grading is completed.

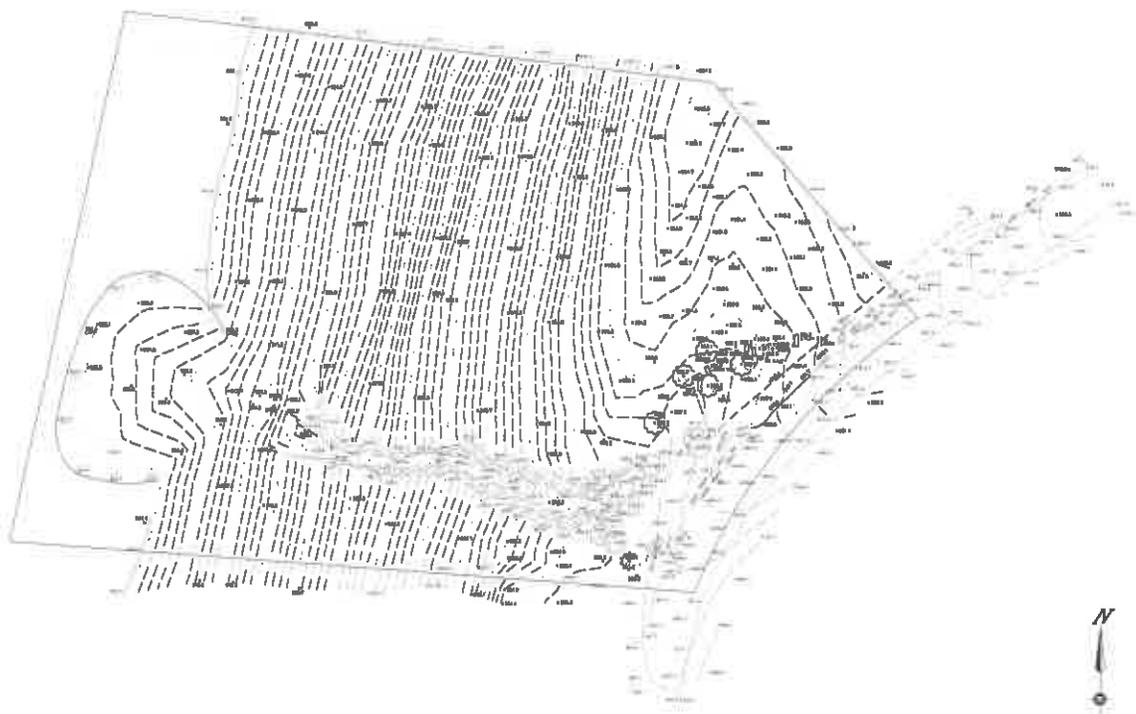
Figure 1

Erosion was initiated in late 2018 and continued through 2019. A large gully, approximately 200 feet in length and between 15 and 20 feet wide, formed running from east to west and generally parallel with and 50 feet north of the south property line. See plans attached.

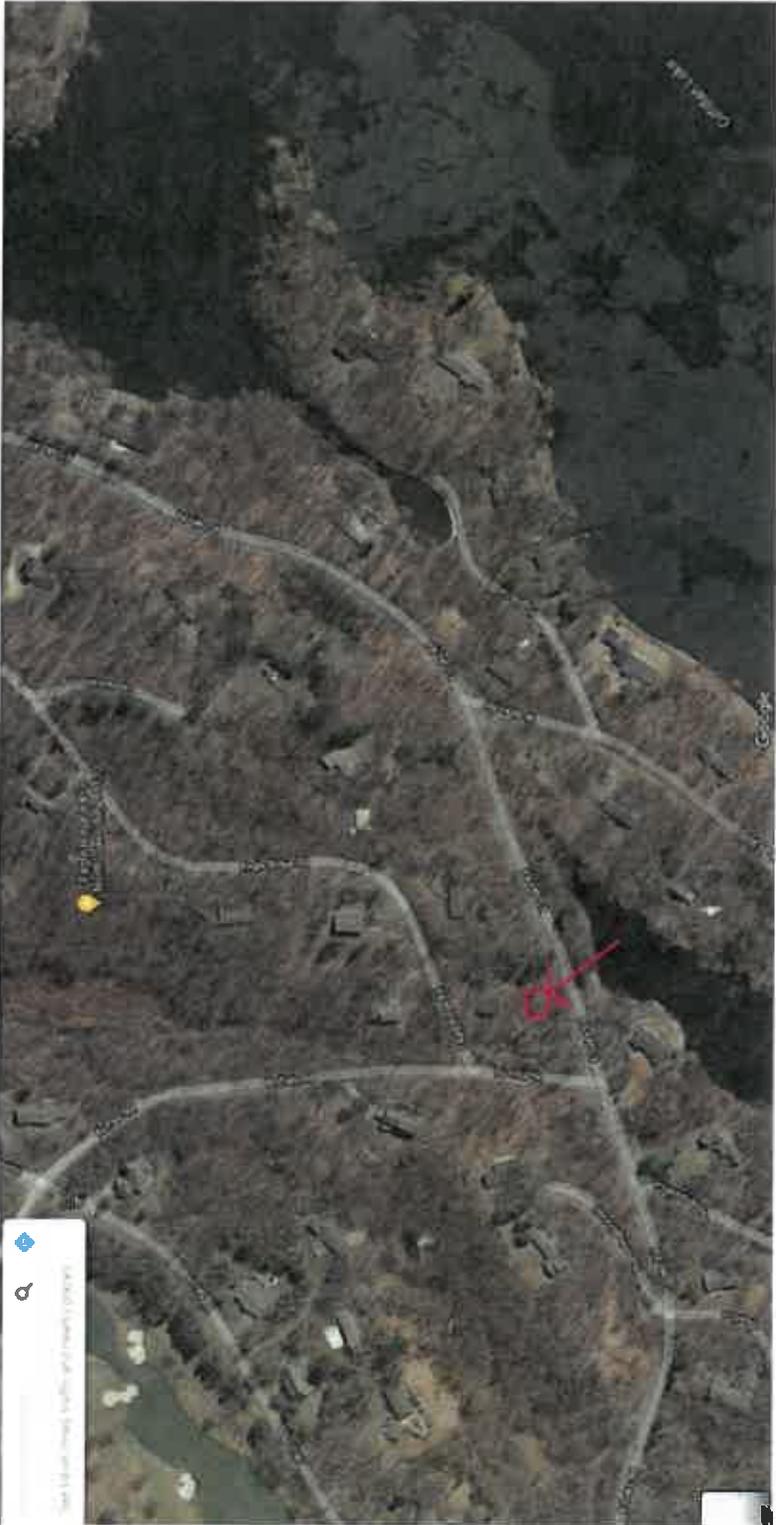
EXHIBIT 1 – STOCKPILE LOCATION

North is to the LEFT.
Stockpile is shown with red arrow.
7 Eagle Ridge Road is shown with yellow pin.

Another stockpile of soils remaining from a nearby construction excavation are available at no cost but includes a short haul. Location of this stockpile is shown in Exhibit 1 attached. To access this material, contact **Steve Finnegan at 612-868-9515** to coordinate on removal.

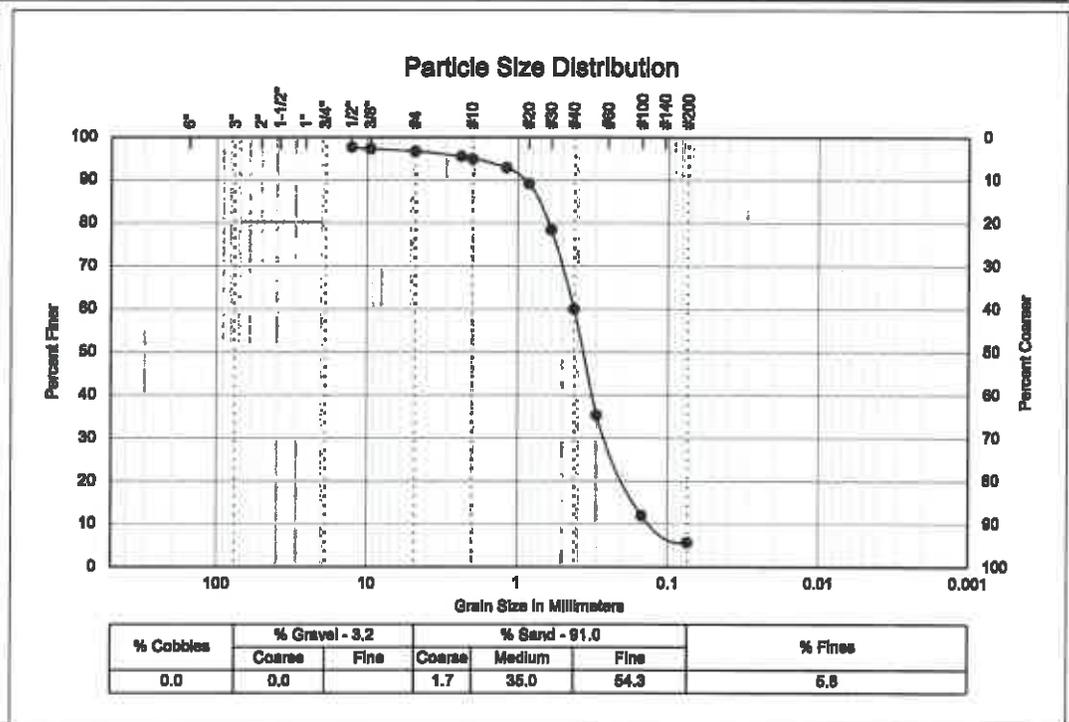
Sample Type: Bulk
 Sample Location: TOPSOIL
 Sample Description: Poorly-Graded Sand with Silt (SP-SM), Brown

$D_{60} = 0.42$	$D_{30} = 0.27$	$D_{10} = 0.135$	$C_c = 1.3$	$C_u = 3.1$	FM =
-----------------	-----------------	------------------	-------------	-------------	------

Comments: Organic Content by Loss on Ignition = 4.9%

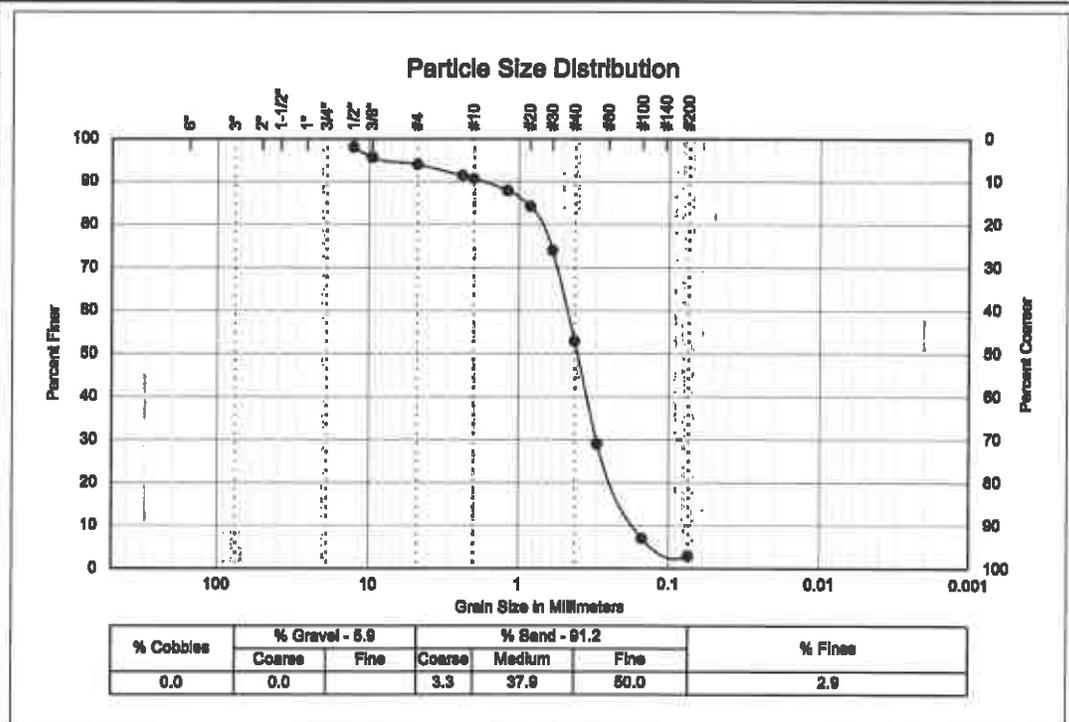
Sample Type: Bulk
 Sample Location: DELTA
 Sample Description: Poorly-Graded Sand (SP), Brown

$D_{60} = 0.47$	$D_{30} = 0.30$	$D_{10} = 0.173$	$C_c = 1.1$	$C_u = 2.7$	FM =
-----------------	-----------------	------------------	-------------	-------------	------

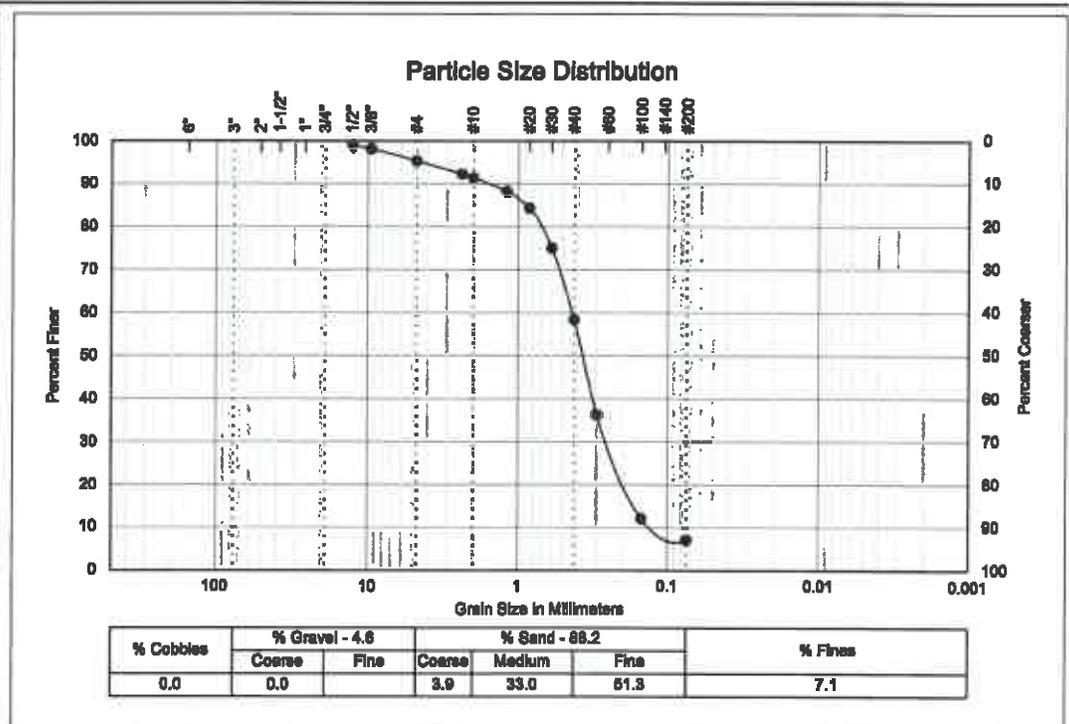
Sample Type: Bulk
 Sample Location: G-BOTTOM
 Sample Description: Poorly-Graded Sand with Silt (SP-SM), Brown

$D_{60} = 0.43$	$D_{30} = 0.26$	$D_{10} = 0.133$	$C_c = 1.2$	$C_u = 3.2$	FM =
-----------------	-----------------	------------------	-------------	-------------	------

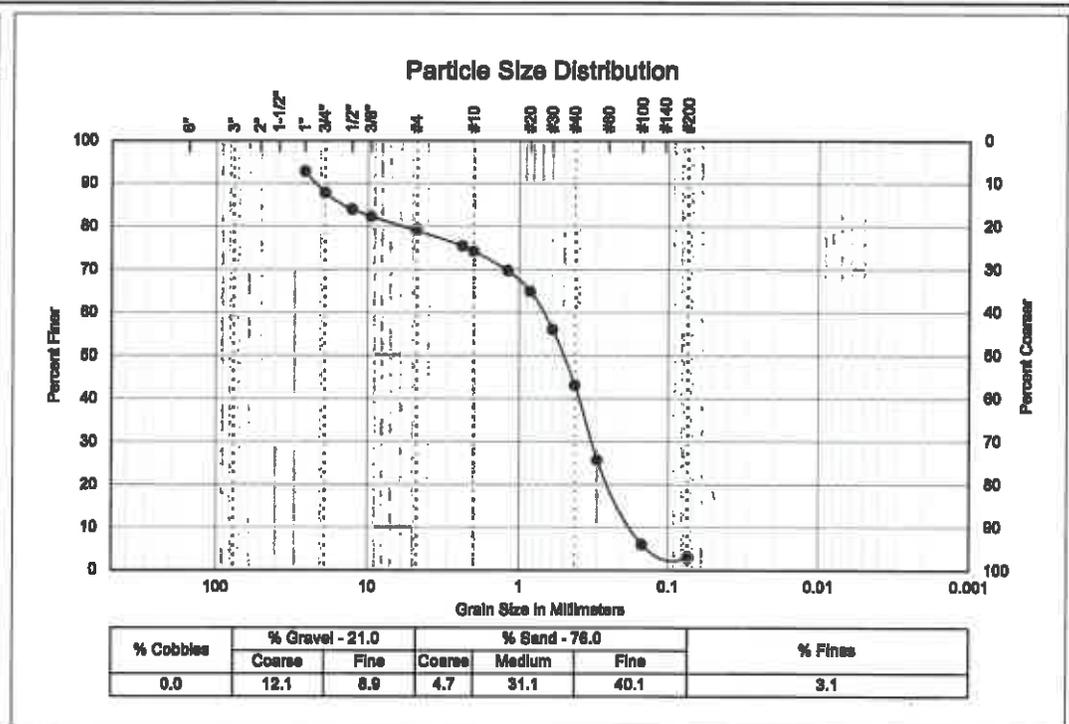
Sample Type: Bulk
 Sample Location: STOCKPILE
 Sample Description: Poorly-Graded Sand (SP), Brown

D ₆₀ = 0.68	D ₃₀ = 0.32	D ₁₀ = 0.181	C _c = 0.8	C _u = 3.7	FM =
------------------------	------------------------	-------------------------	----------------------	----------------------	------

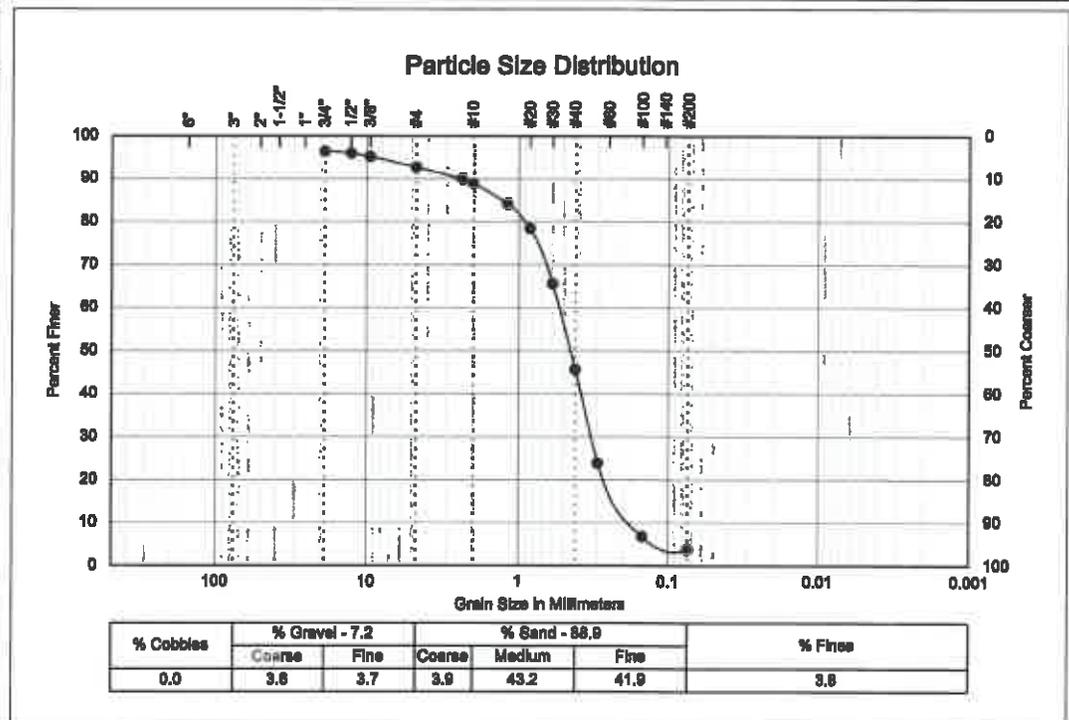
Sample Type: Bulk
 Sample Location: G-TOP
 Sample Description: Poorly-Graded Sand (SP), Brown

$D_{60} = 0.54$	$D_{30} = 0.33$	$D_{10} = 0.188$	$C_c = 1.1$	$C_u = 2.9$	FM =
-----------------	-----------------	------------------	-------------	-------------	------
