2015 Annual Monitoring Report

Highway 96 Site
White Bear Township, Minnesota

Highway 96 Group

1801 Old Highway 8 Northwest Suite 114 St. Paul Minnesota 55112
002012 | Report No 66 | March 14 2016

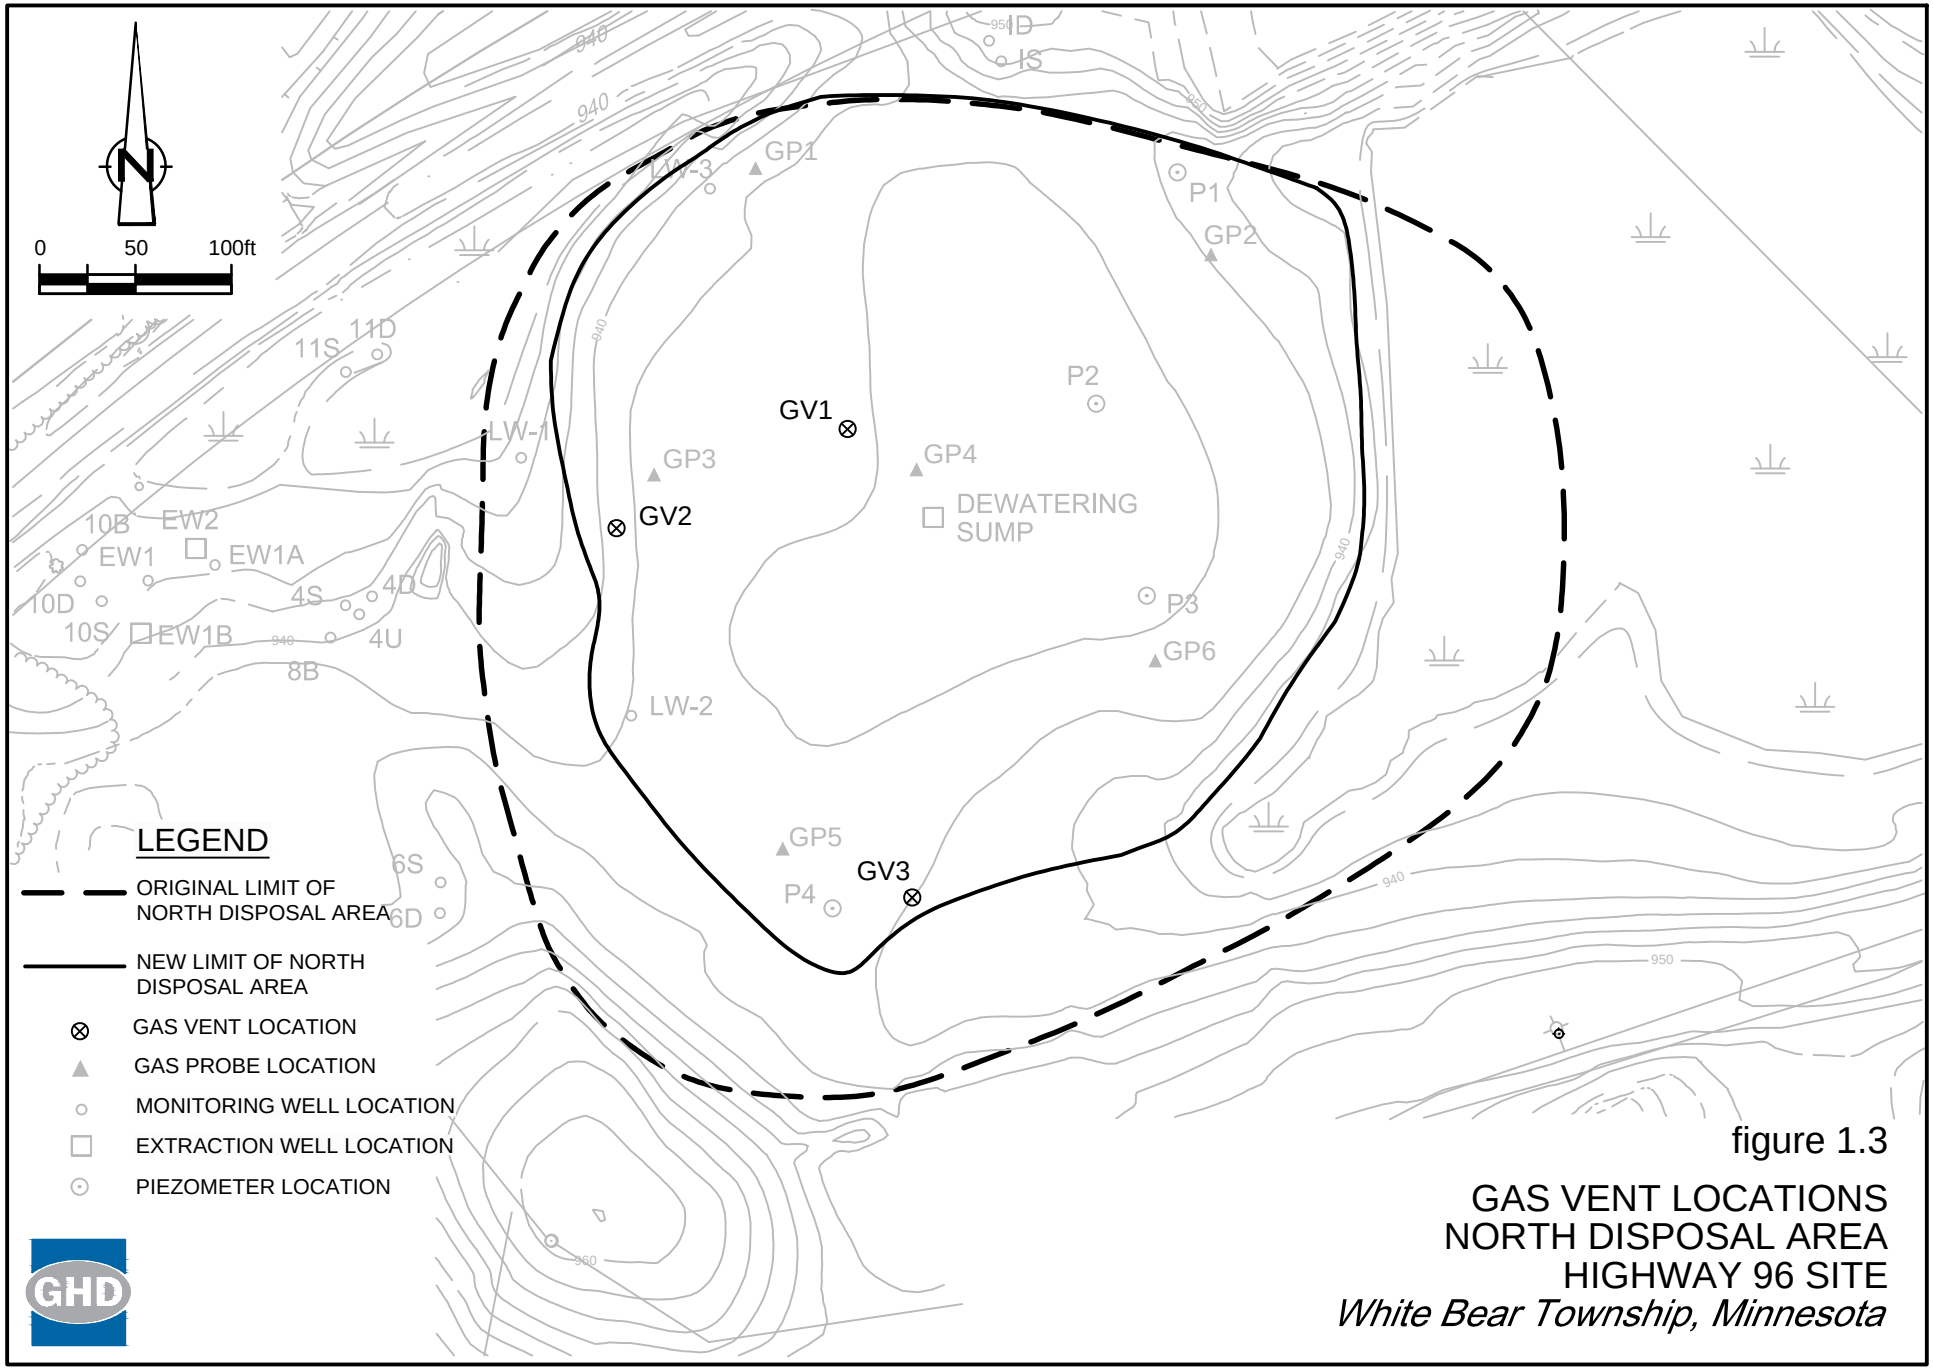
figure 1.3

In response to the MPCA's comments to the Remedial Action Final Report, three passive methane vents were installed in the CWA in November of 1996 as shown on Figure 1.3. The vents were screened across the entire thickness of the waste to allow for future drawdown due to the operation of the dewatering sump.

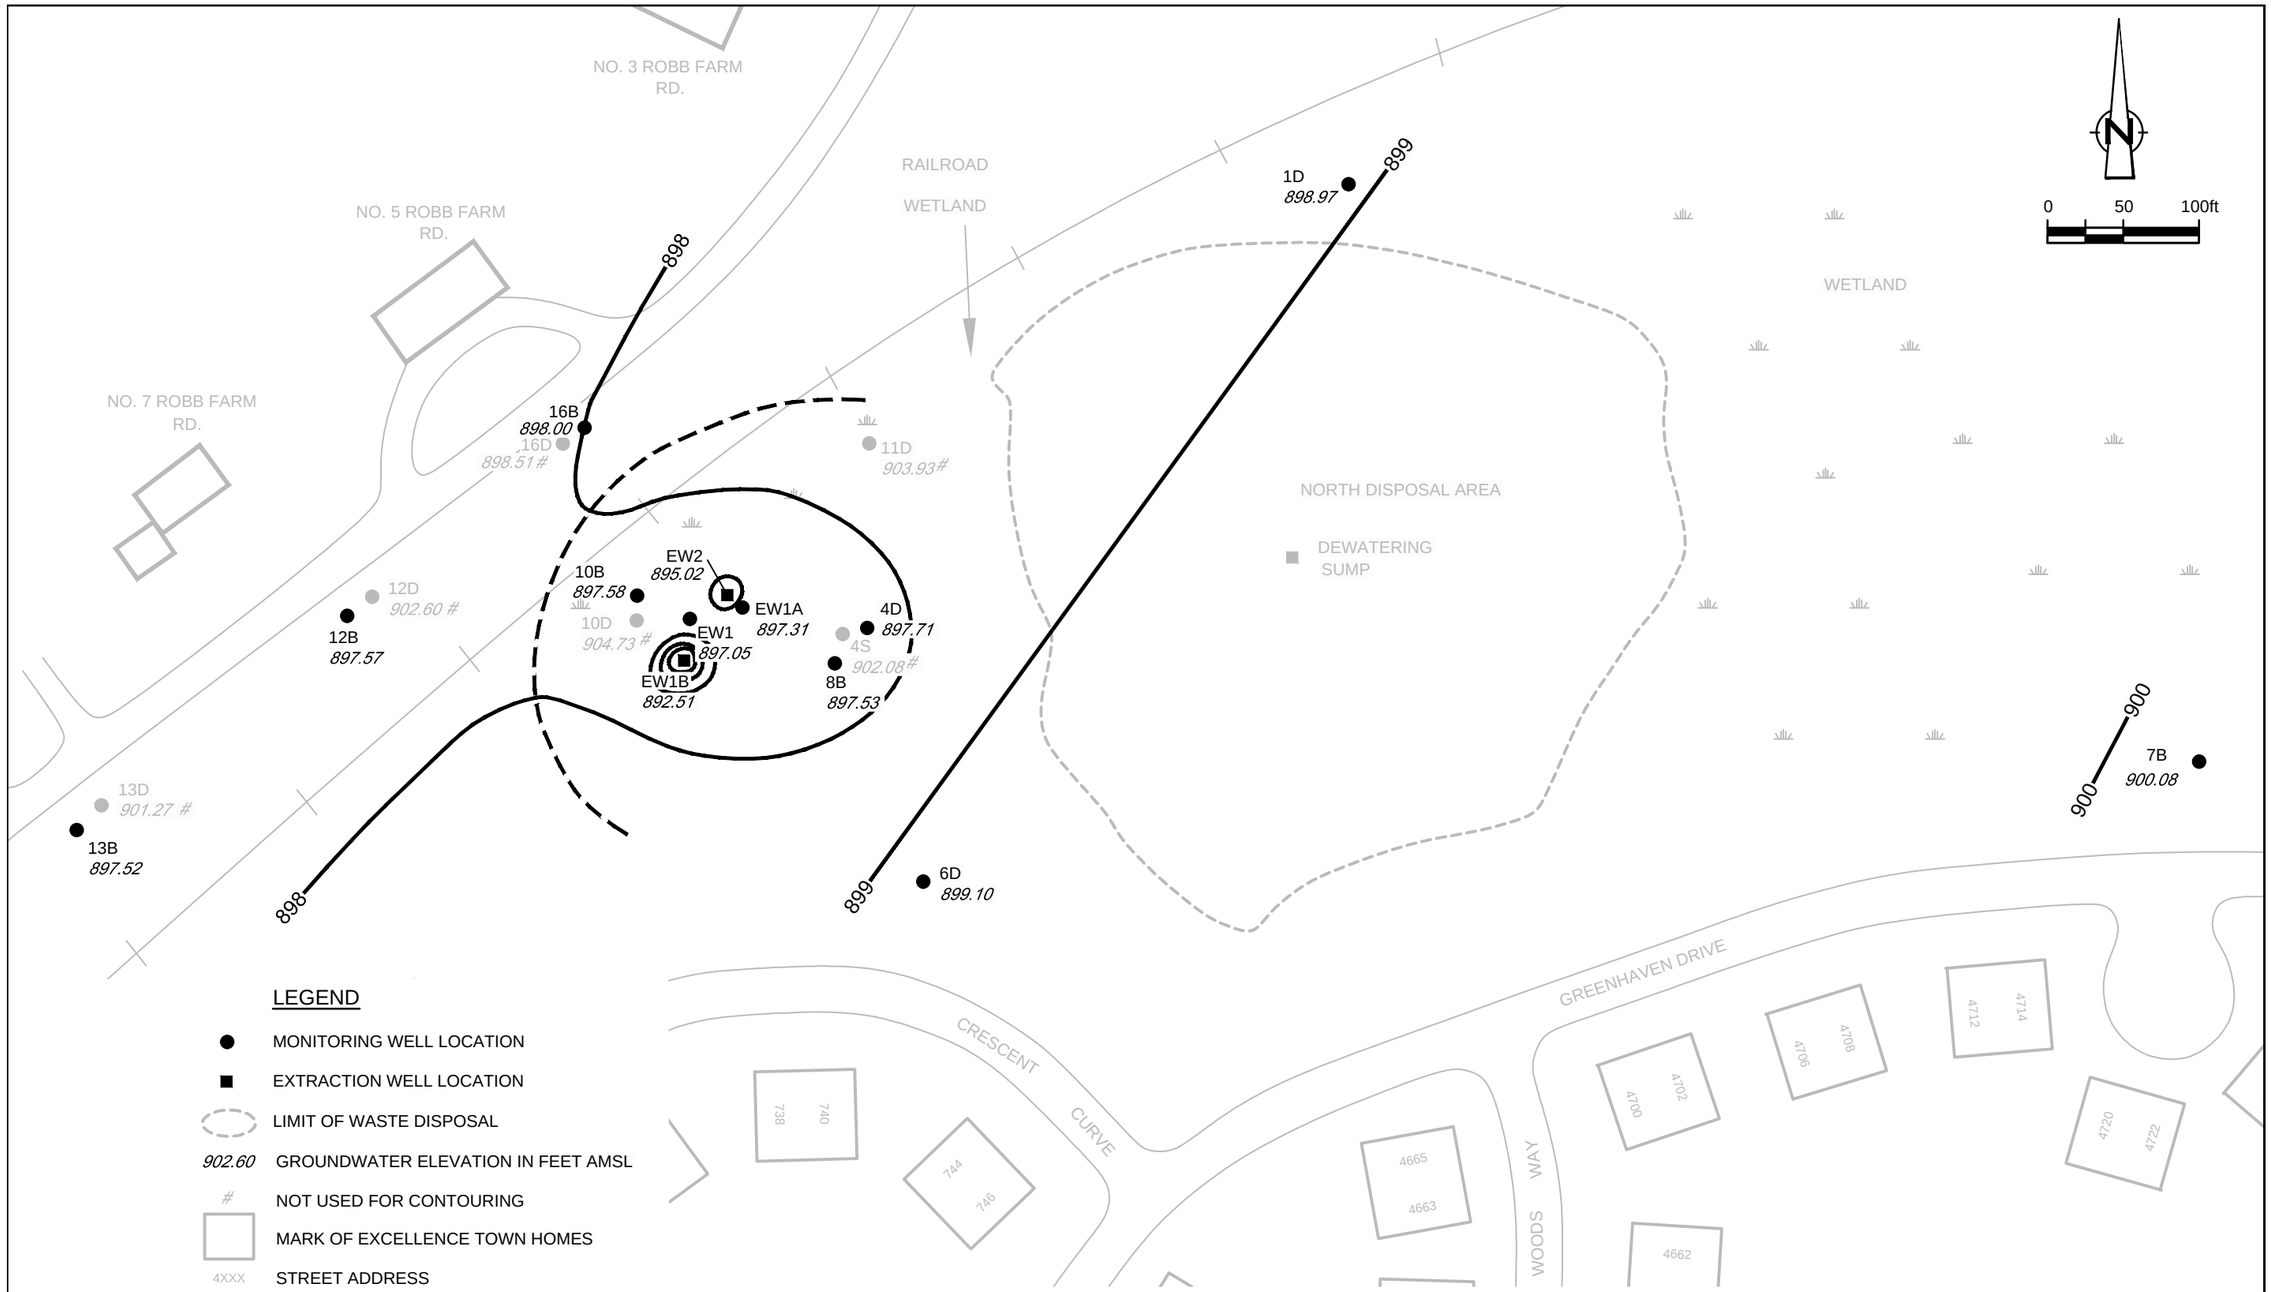
LOWER SAND/ST. PETER SANDSTONE AQUIFER
GROUNDWATER ELEVATIONS (OCTOBER 5, 2015)
HIGHWAY 96 SITE
White Bear Township, Minnesota

October 2015 on-Site groundwater contours for the Lower Sand/St. Peter Sandstone aquifers are presented on Figure 3.3. The groundwater contours depict the influence of the groundwater extraction system (see Section 3.3). Overall, groundwater elevations continue to reflect the heterogeneous nature of the Lower Sand aquifer. As noted on Figure 3.3, some Lower Sand aquifer monitoring locations (e.g., MW10D) are not used for groundwater contouring because they are screened in areas of low permeability soil (i.e., higher silt/clay content).

A groundwater capture analysis was presented in CRA's July 2010 report (Ref. 19). The report recommended the groundwater extraction system operate at a combined pumping rate (of EW1B and EW2) between 13 and 20 gpm to obtain a groundwater capture width of 200-300 ft and achieve sufficient hydraulic containment. Based on the 2015 average combined pumping rate of 19.6 gpm (see Table 3.2), the groundwater capture width in the Lower Sand aquifer and the upper portion of the St. Peter Sandstone aquifer is approximately 300 feet (measured at the pumping source). Groundwater elevation measurements collected on October 5, 2015 also provide verification of hydraulic containment of the VOC plume (see Figure 3.3).

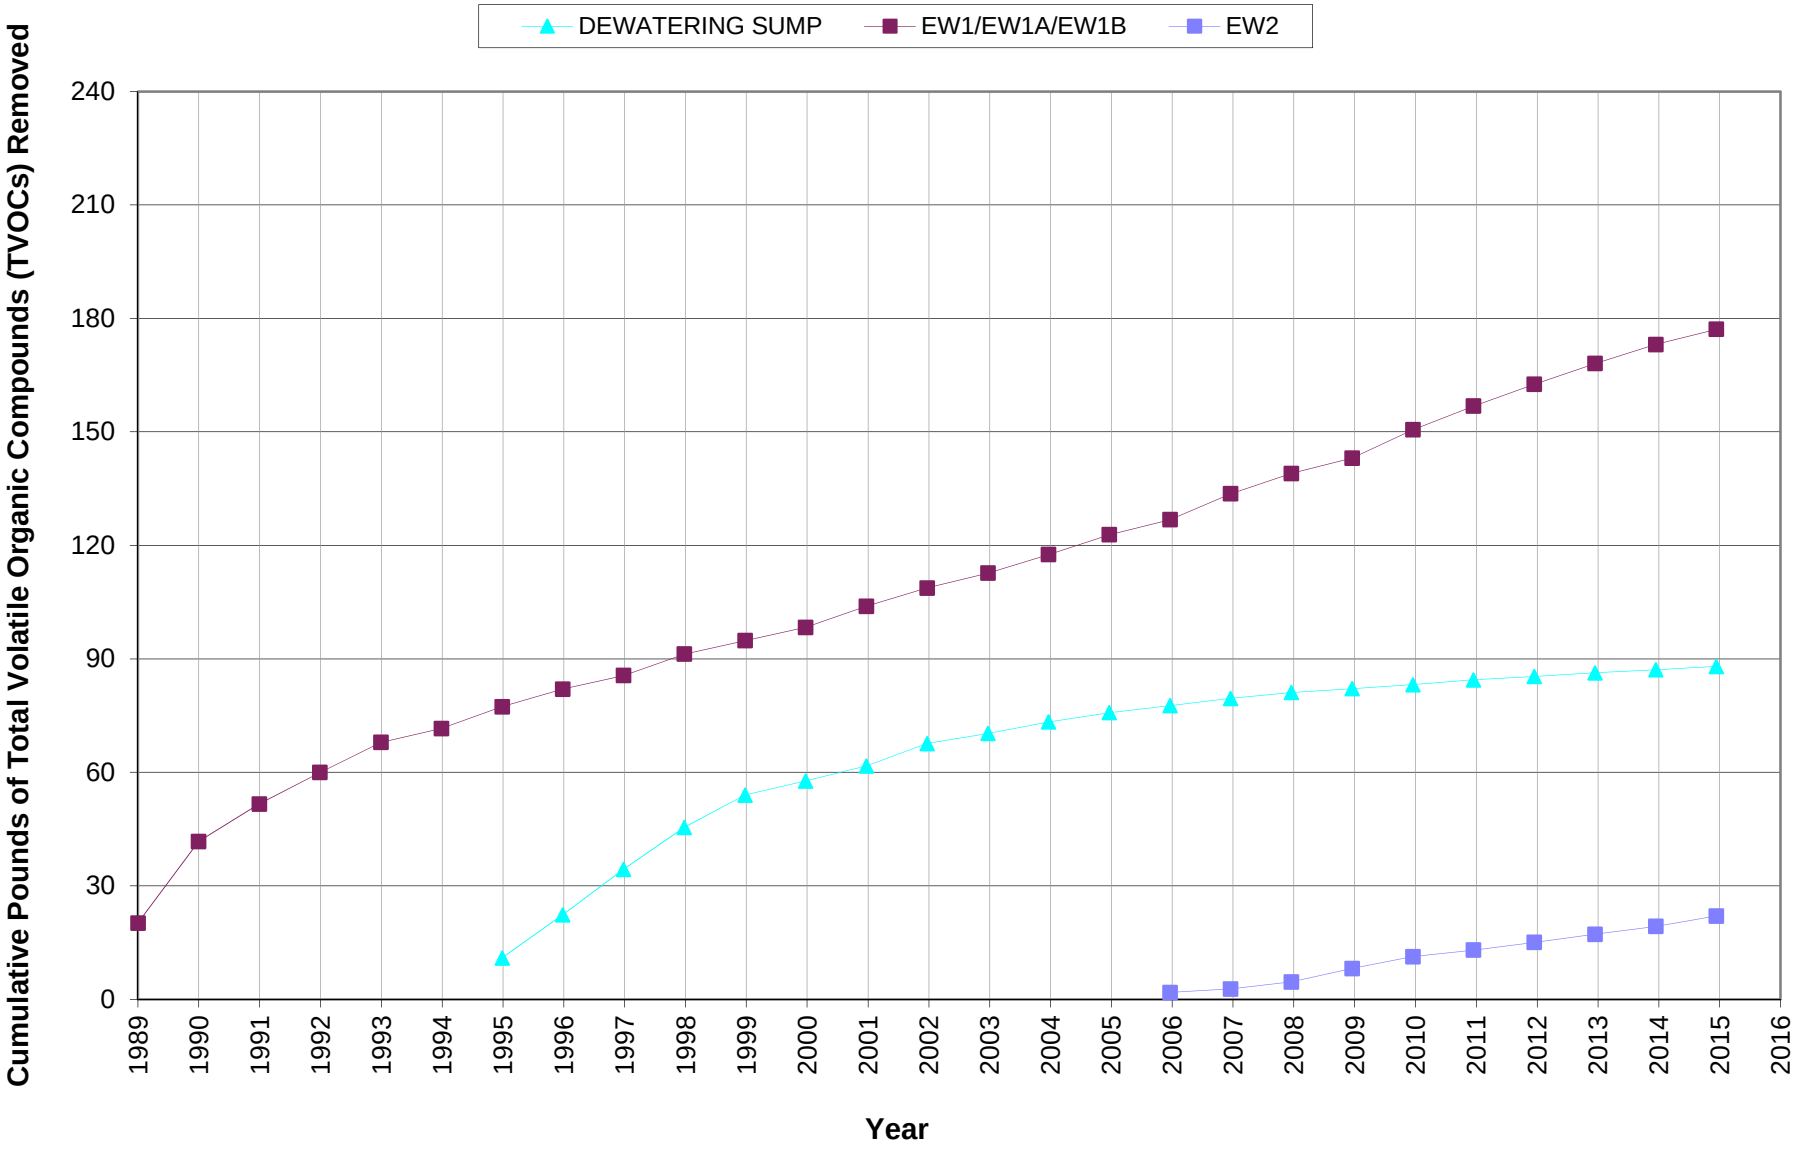
per million gallons) of EW1/EW1A/EW1B since 1989. Figure 3.9 shows cumulative VOC mass removal by EW1/EW1A/EW1B since 1989.

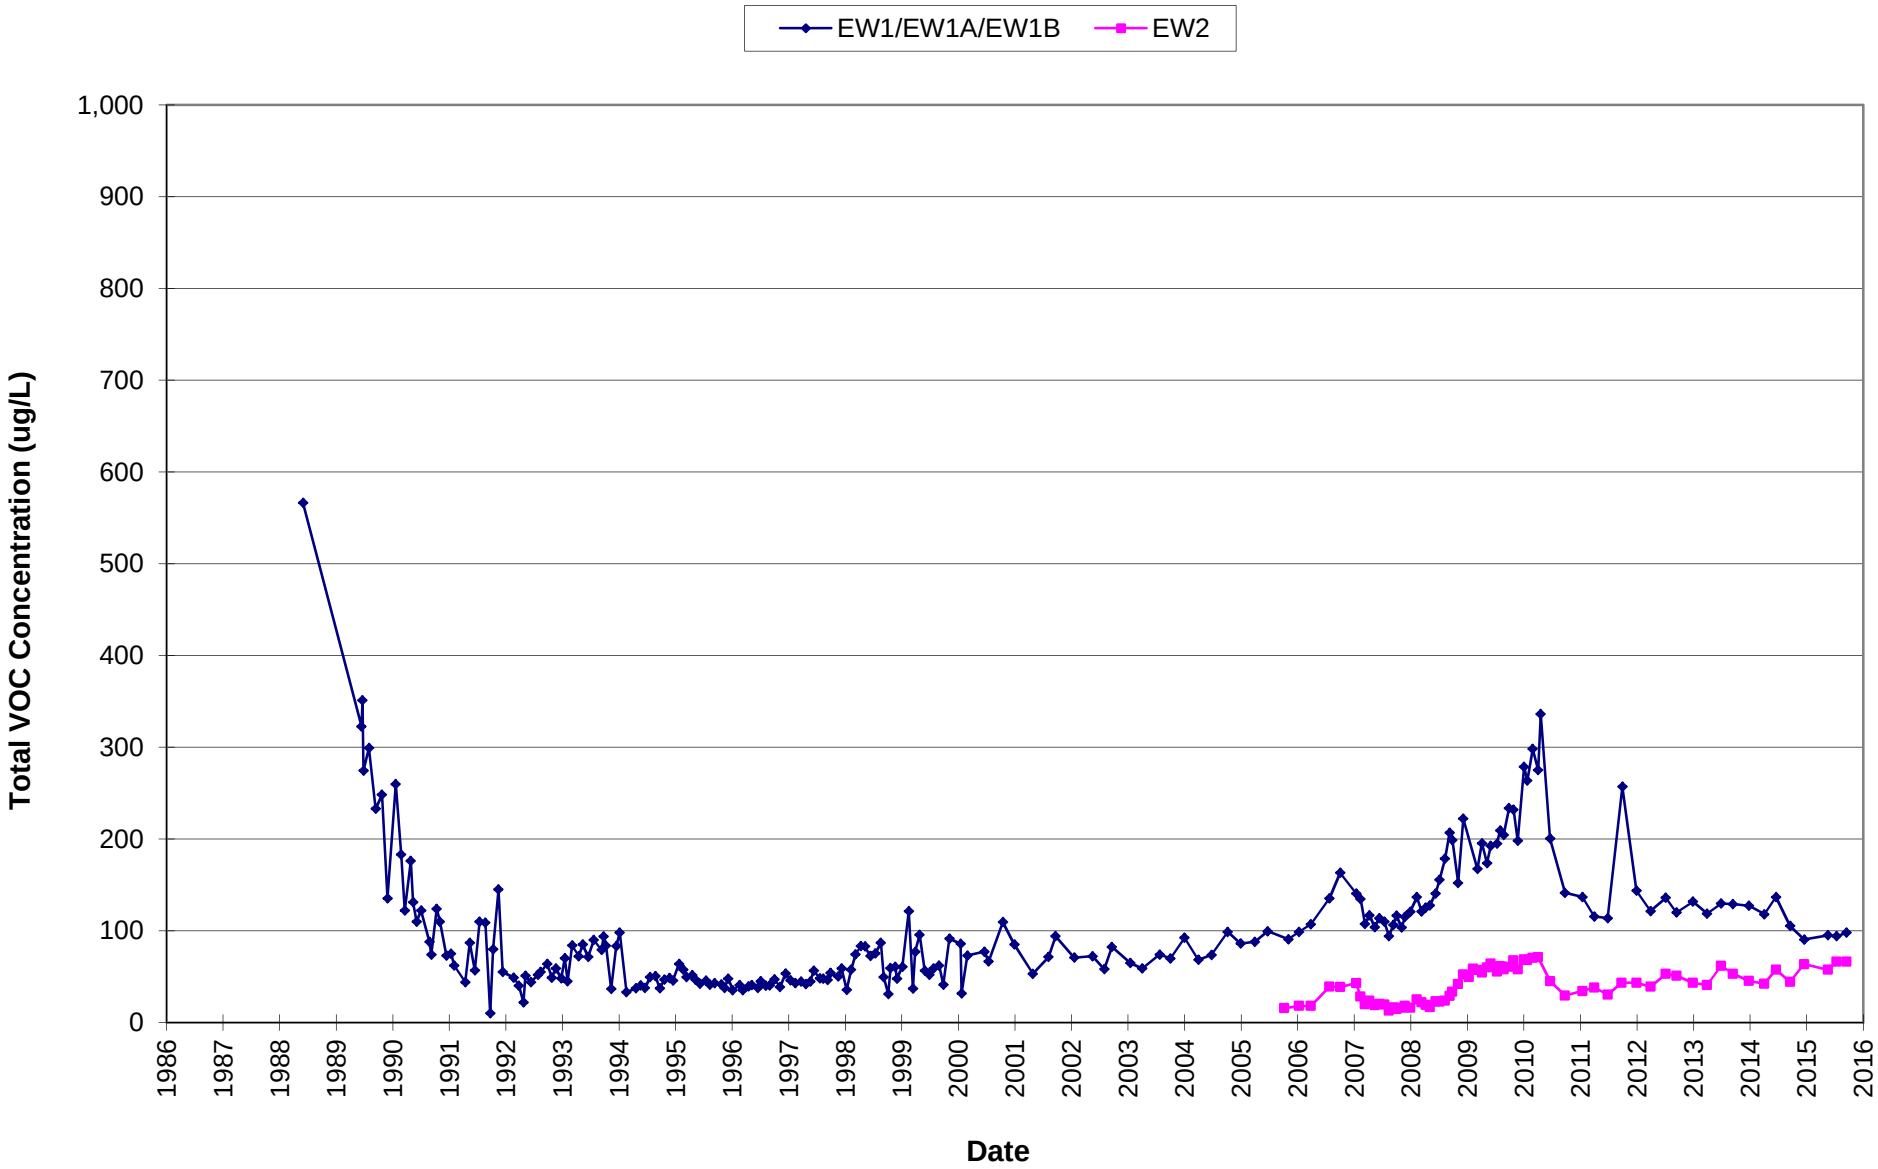
- EW1/EW1A/EW1B data represent groundwater from the Lower Sand and St. Peter Sandstone aquifers that is captured by the extraction system. Figure 3.10 illustrates TVOC concentrations at EW1/EW1A/EW1B (see Section 3.3.).
- MW12D data represent groundwater in the Lower Sand aquifer downgradient of the extraction system. Figure 4.3 illustrates TVOC concentrations at MW12D, which have historically remained below 3 µg/L since 1997. In October 1996, the TVOC concentration was near 400 µg/L. That sample result is considered anomalous because TVOC concentrations were not observed at or near that level prior to or after that sample date. In October 2015, the TVOC concentration at MW12D was 0.3 μg/L.

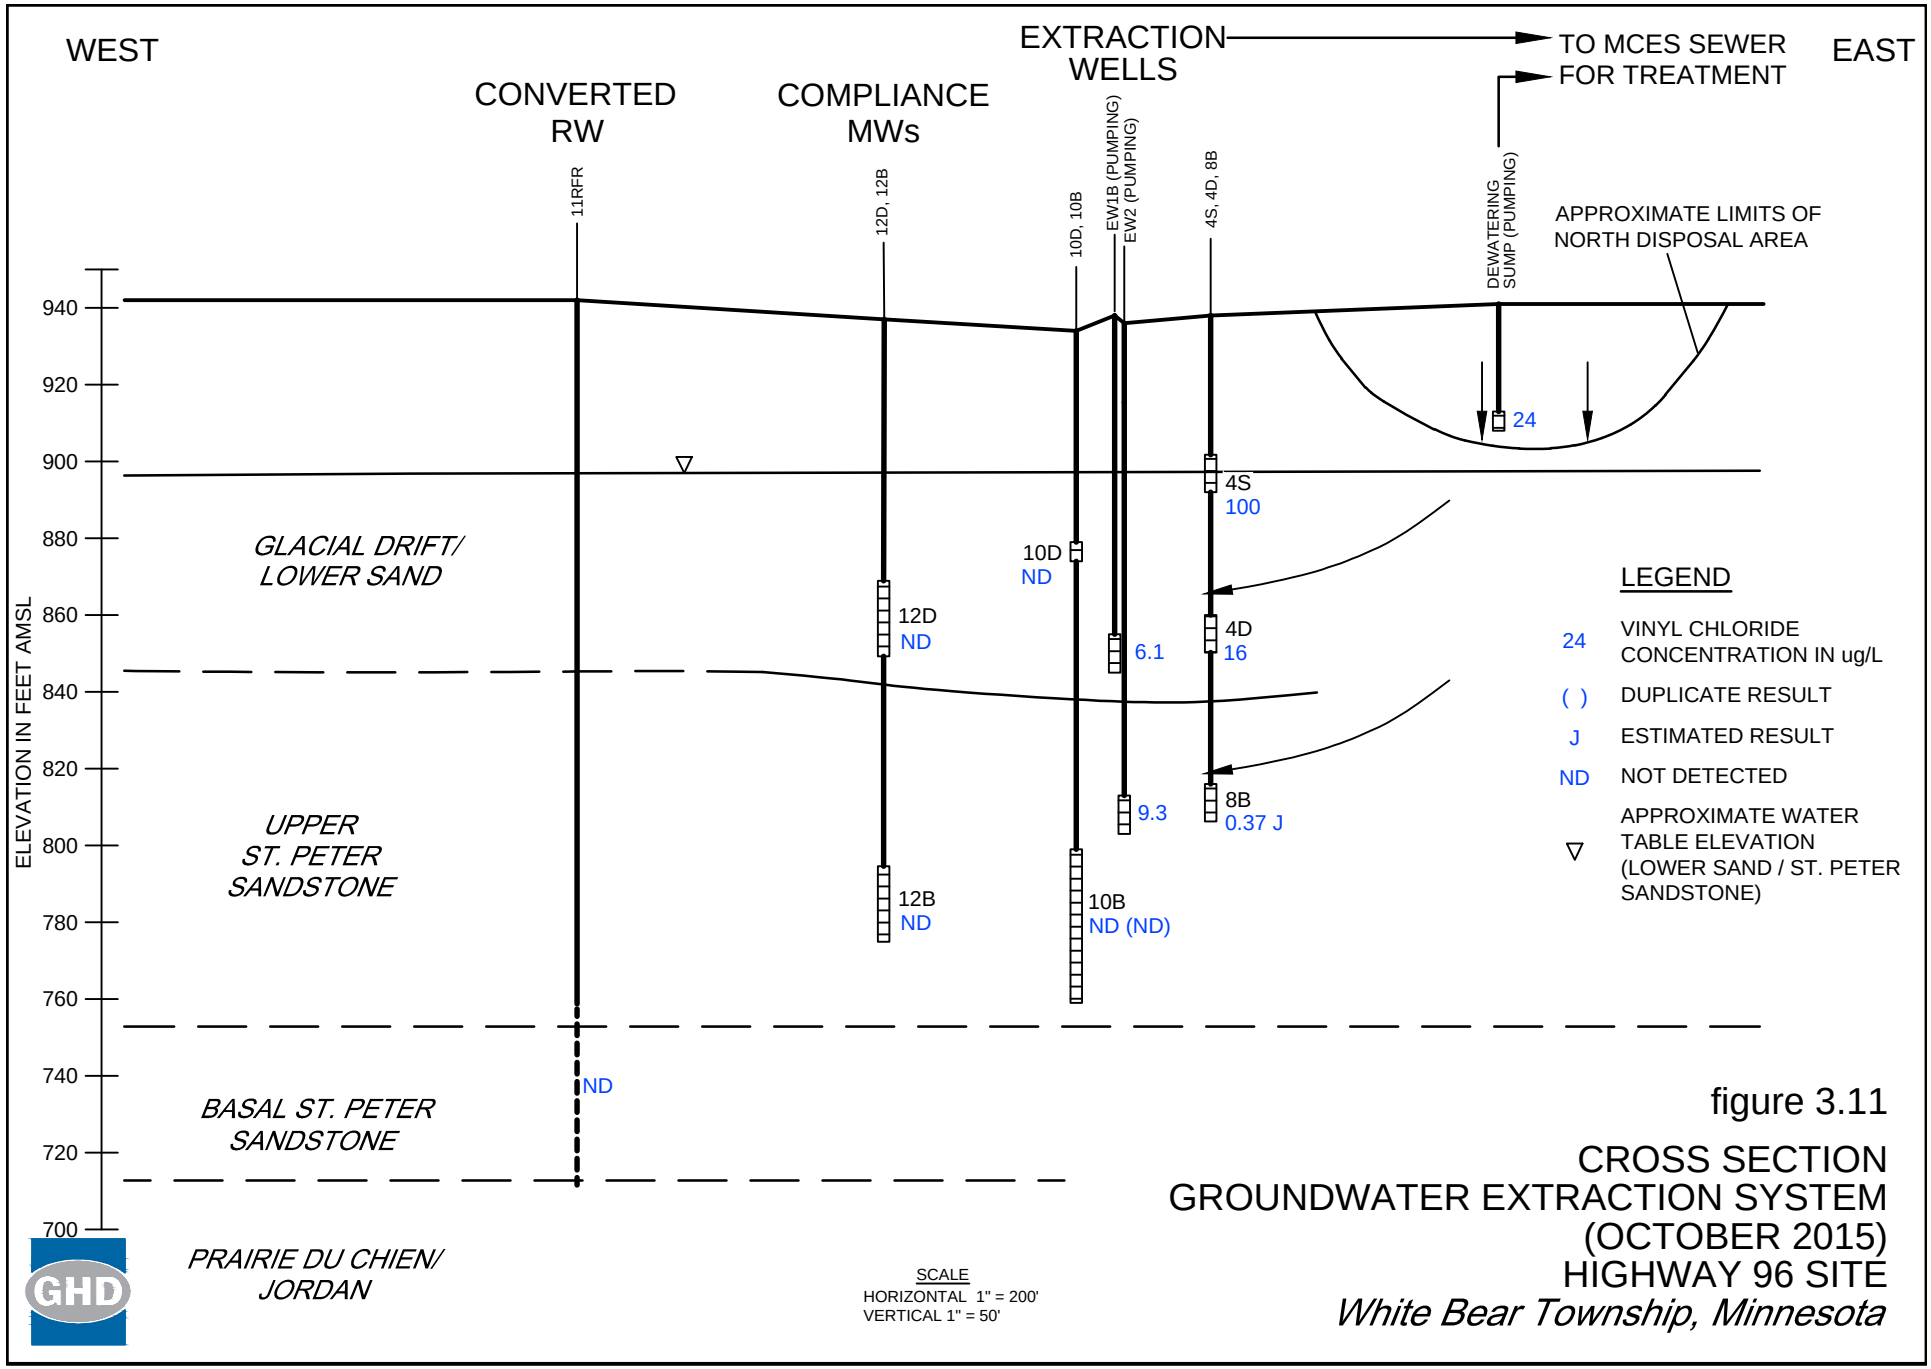
figure 3.11

Figure 3.11 presents a cross-section that depicts subsurface conditions in the vicinity of the groundwater extraction system. As shown on Figure 3.11, the groundwater extraction system effectively captures contaminated groundwater from upgradient areas (e.g., as screened by monitoring wells MW4D and MW8B). The effectiveness of the groundwater extraction system is demonstrated by low to non-detectable VOC concentrations at downgradient compliance wells and the converted residential monitoring wells.

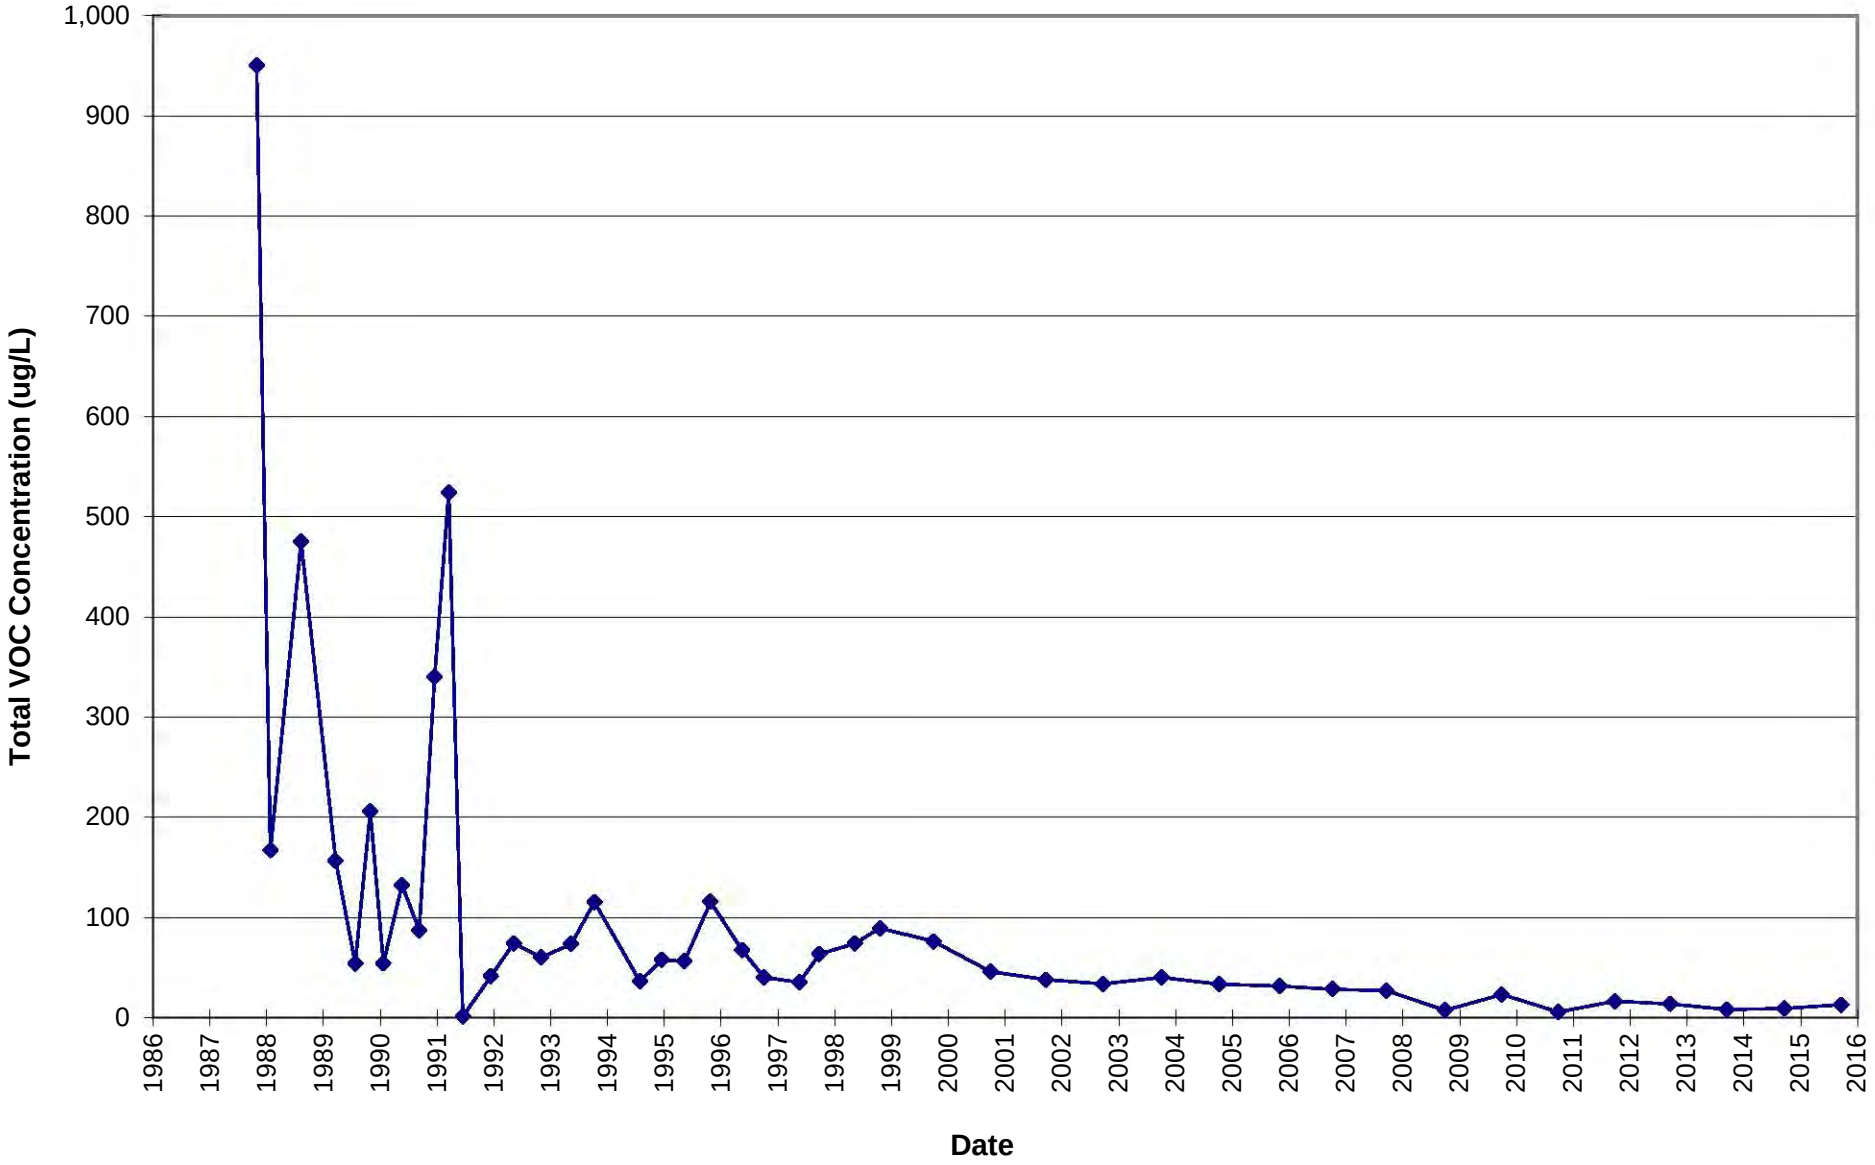
TVOC concentrations in the perched groundwater unit are represented by LW3 (Figure 4.1).

- LW3 data represent perched groundwater beneath the limits of the CWA. Figure 4.1 illustrates TVOC concentrations in the perched groundwater unit decreasing from 1987 through 1991, and remaining relatively stable and less than 50 µg/L since 2001. In October 2015, the TVOC concentration at LW3 was 12.62 µg/L.

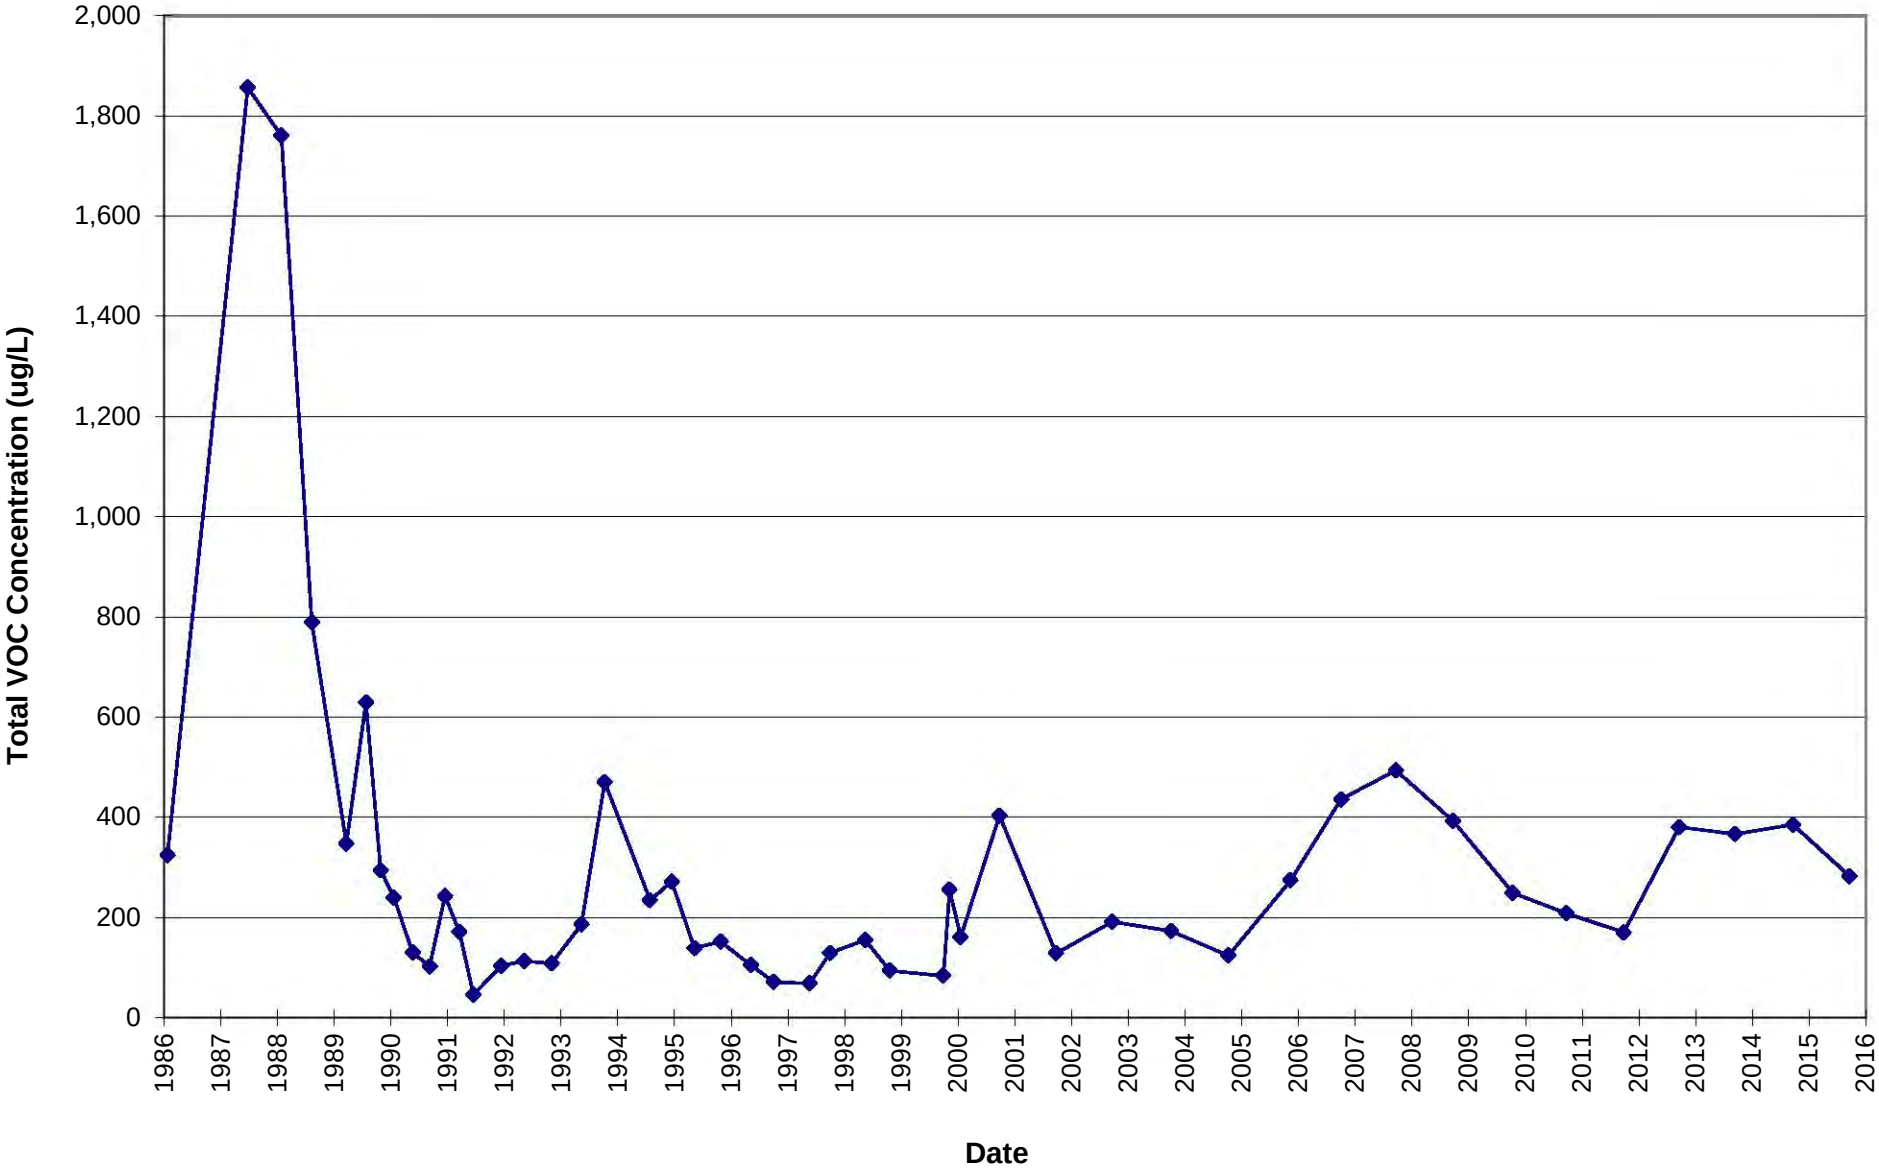
- MW4D data represent groundwater in the Lower Sand aquifer immediately downgradient of the CWA. Figure 4.2 illustrates TVOC concentrations at MW4D decreasing from 1987 through

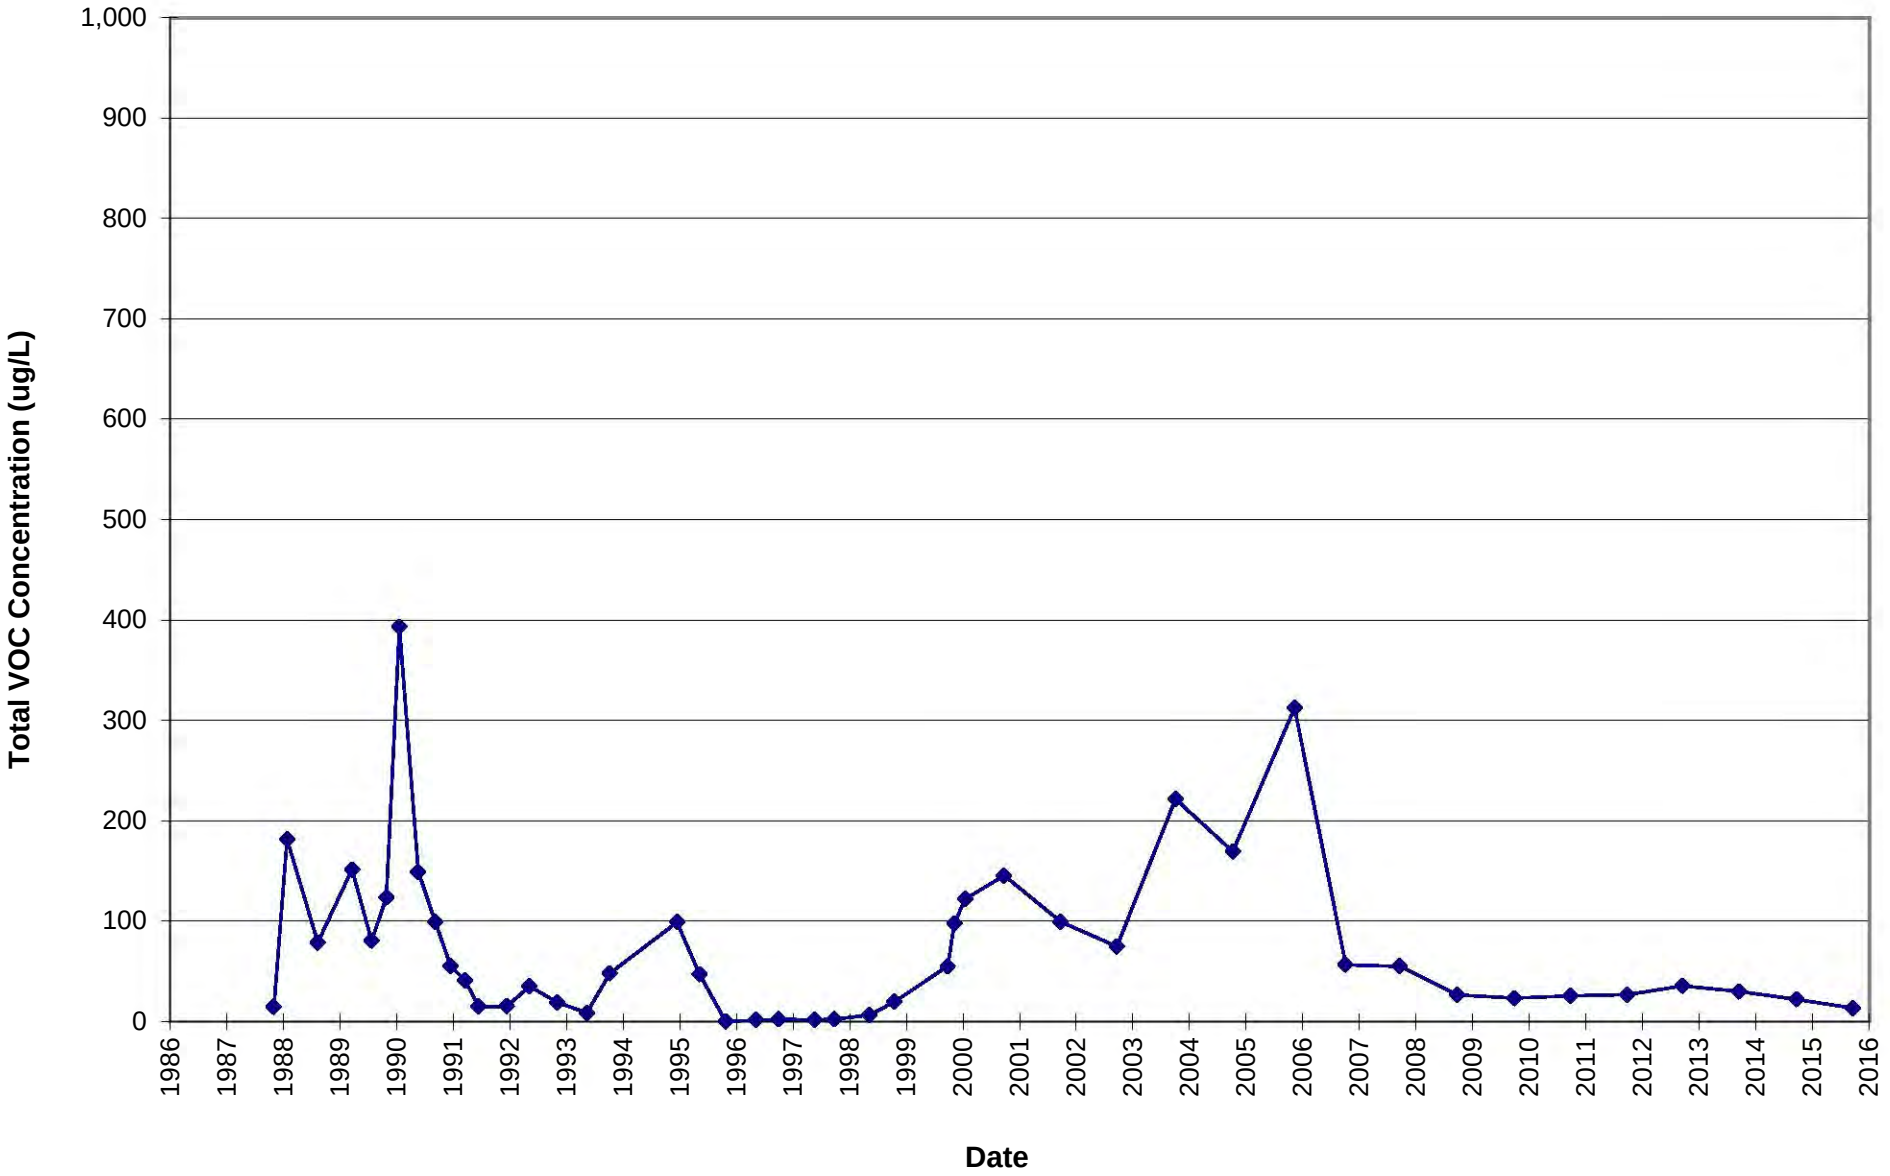
- MW8B is located between the CWA and the groundwater extraction system. MW8B data represent groundwater in the St. Peter Sandstone aquifer immediately downgradient of the CWA. Figure 4.4 illustrates TVOC concentrations at MW8B, which have ranged from 1 μg/L to 300 μg/L over the past 20 years. In October 2015, the TVOC concentration at MW8B was 13.1 μg/L. TVOC concentrations at MW8B have decreased significantly since the commission of extraction well EW2 in January 2006.

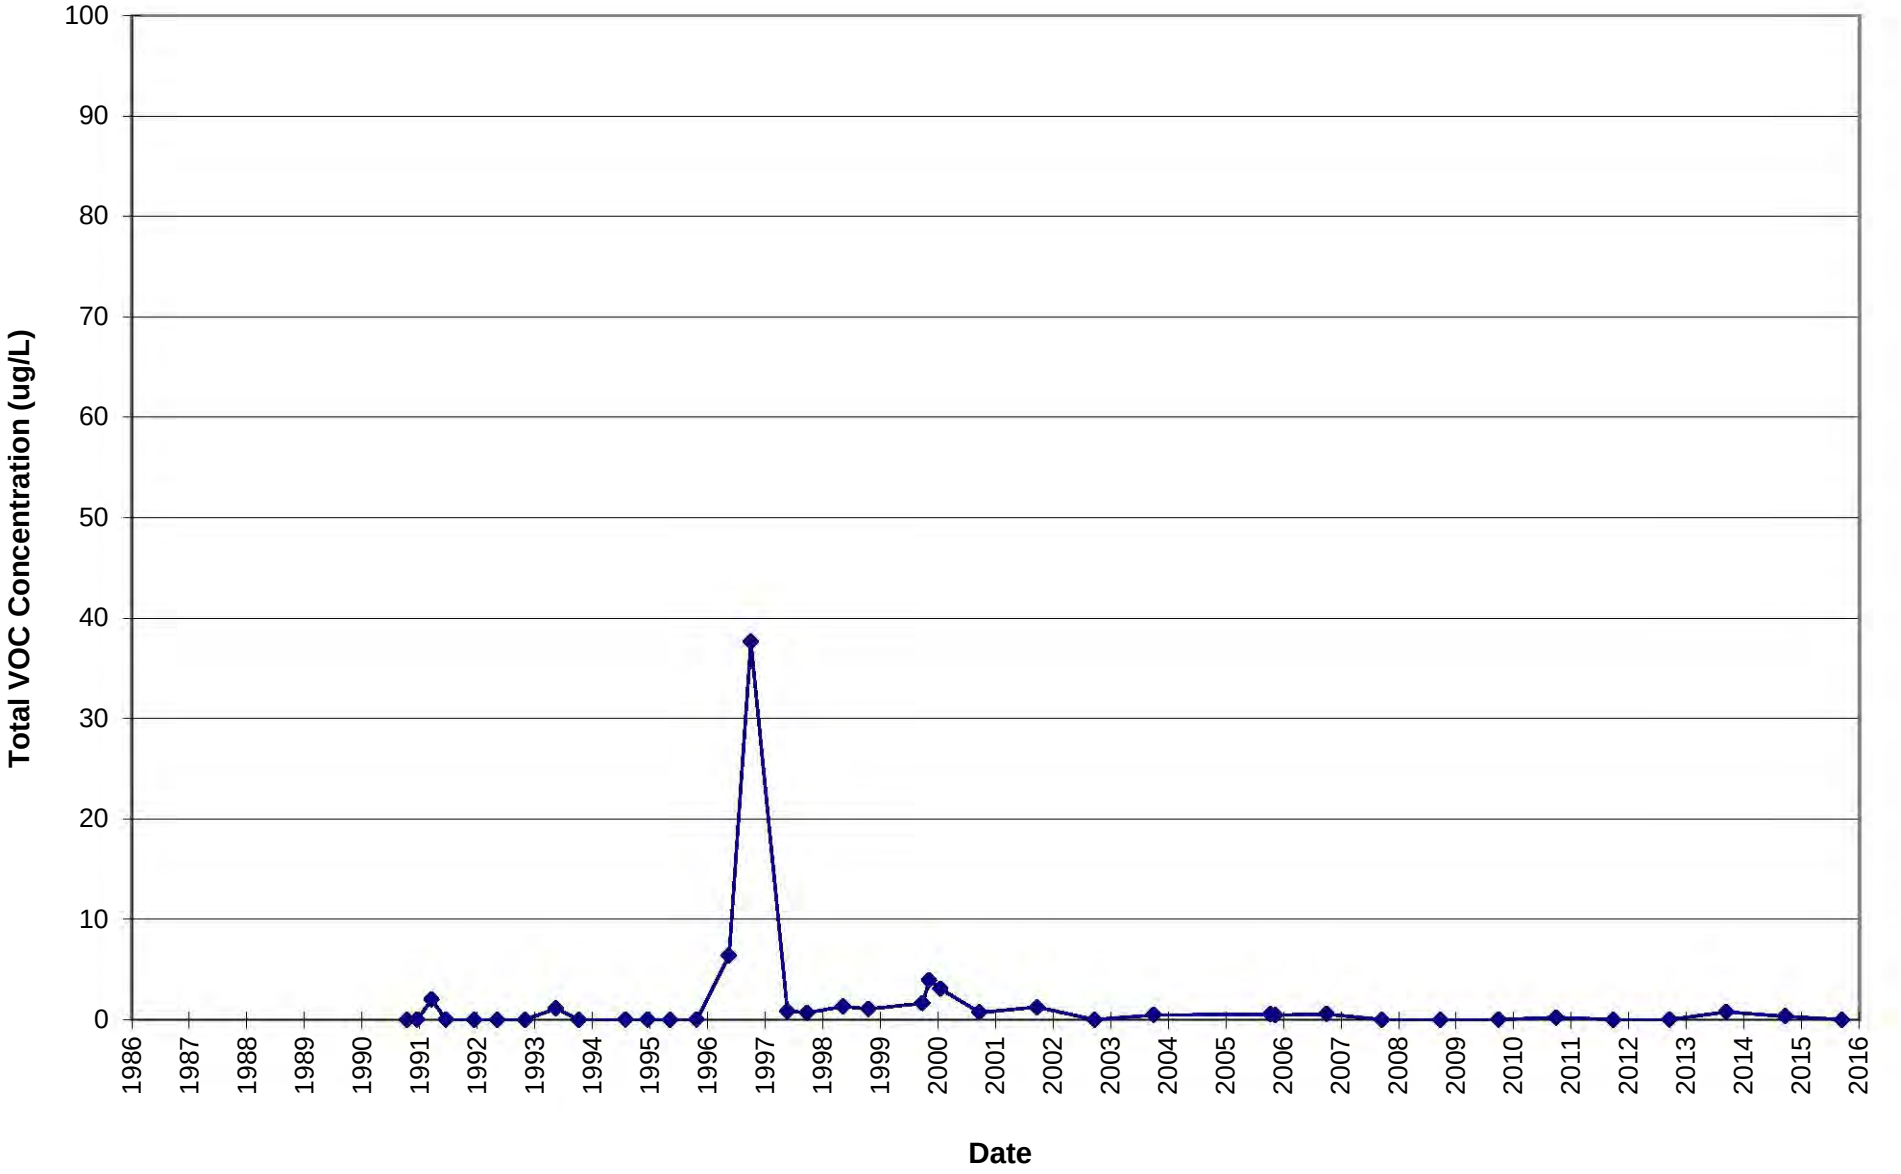
- MW12B data represent groundwater in the St. Peter Sandstone aquifer downgradient of the extraction system. Figure 4.5 illustrates TVOC concentrations at MW12B, which have historically remained below 6 µg/L since 1997. In October 2015, there were no VOCs detected at MW12B.
