2015 Annual Monitoring Report

Highway 96 Site
White Bear Township, Minnesota

Highway 96 Group

1801 Old Highway 8 Northwest Suite 114 St. Paul Minnesota 55112
002012 | Report No 66 | March 14 2016

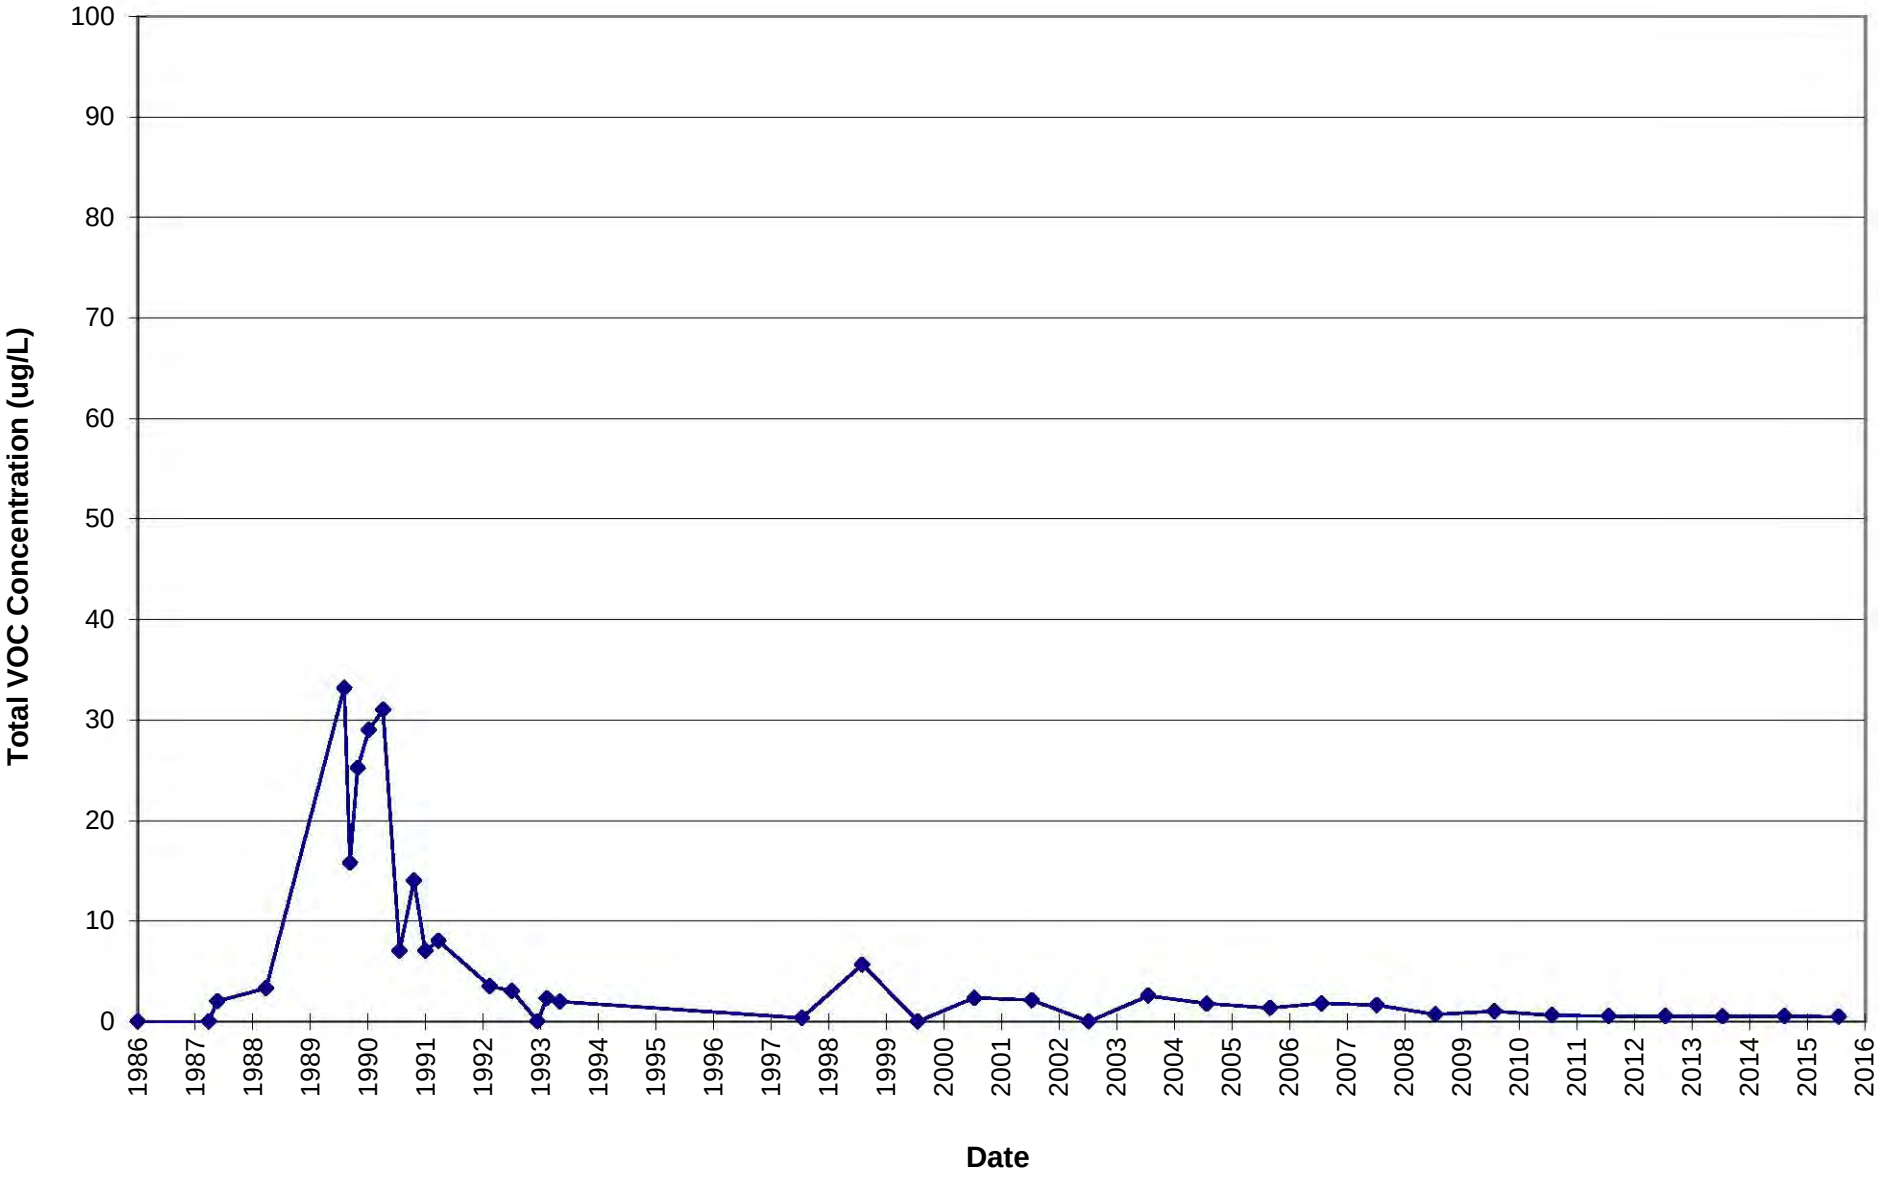
- Data from the four converted residential monitoring wells represent groundwater in the St. Peter Sandstone aquifer further downgradient of the Highway 96 Site. Figure 4.6 illustrates that TVOC concentrations at 11 Robb Farm Road decreased from 1989 through 1992 and have remained relatively stable (below 10 µg/L) since 1990. In October 2015, the TVOC concentration at 11 Robb Farm Road was 0.45 µg/L. Figure 4.7 illustrates that TVOC concentrations at 1 Lily Pond Road have fluctuated between not detected and 30 µg/L since sampling began in 1990. In October 2015, the TVOC concentration at 1 Lily Pond Road was 13.1 µg/L. Figure 4.8 illustrates that TVOC concentrations at 11 Lily Pond Road have typically remained below 5 µg/L since 1996. In October 2015, there were no VOCs detected at 11 Lily Pond Road. Figure 4.9 illustrates that TVOC concentrations at 6 Blue Goose Road have remained below 5 µg/L since 1997. In October 2015, there were no VOCs detected at 6 Blue Goose Lane. The overall decline of TVOC concentrations at the four converted residential well locations can be attributed to Site remediation activities and natural attenuation.

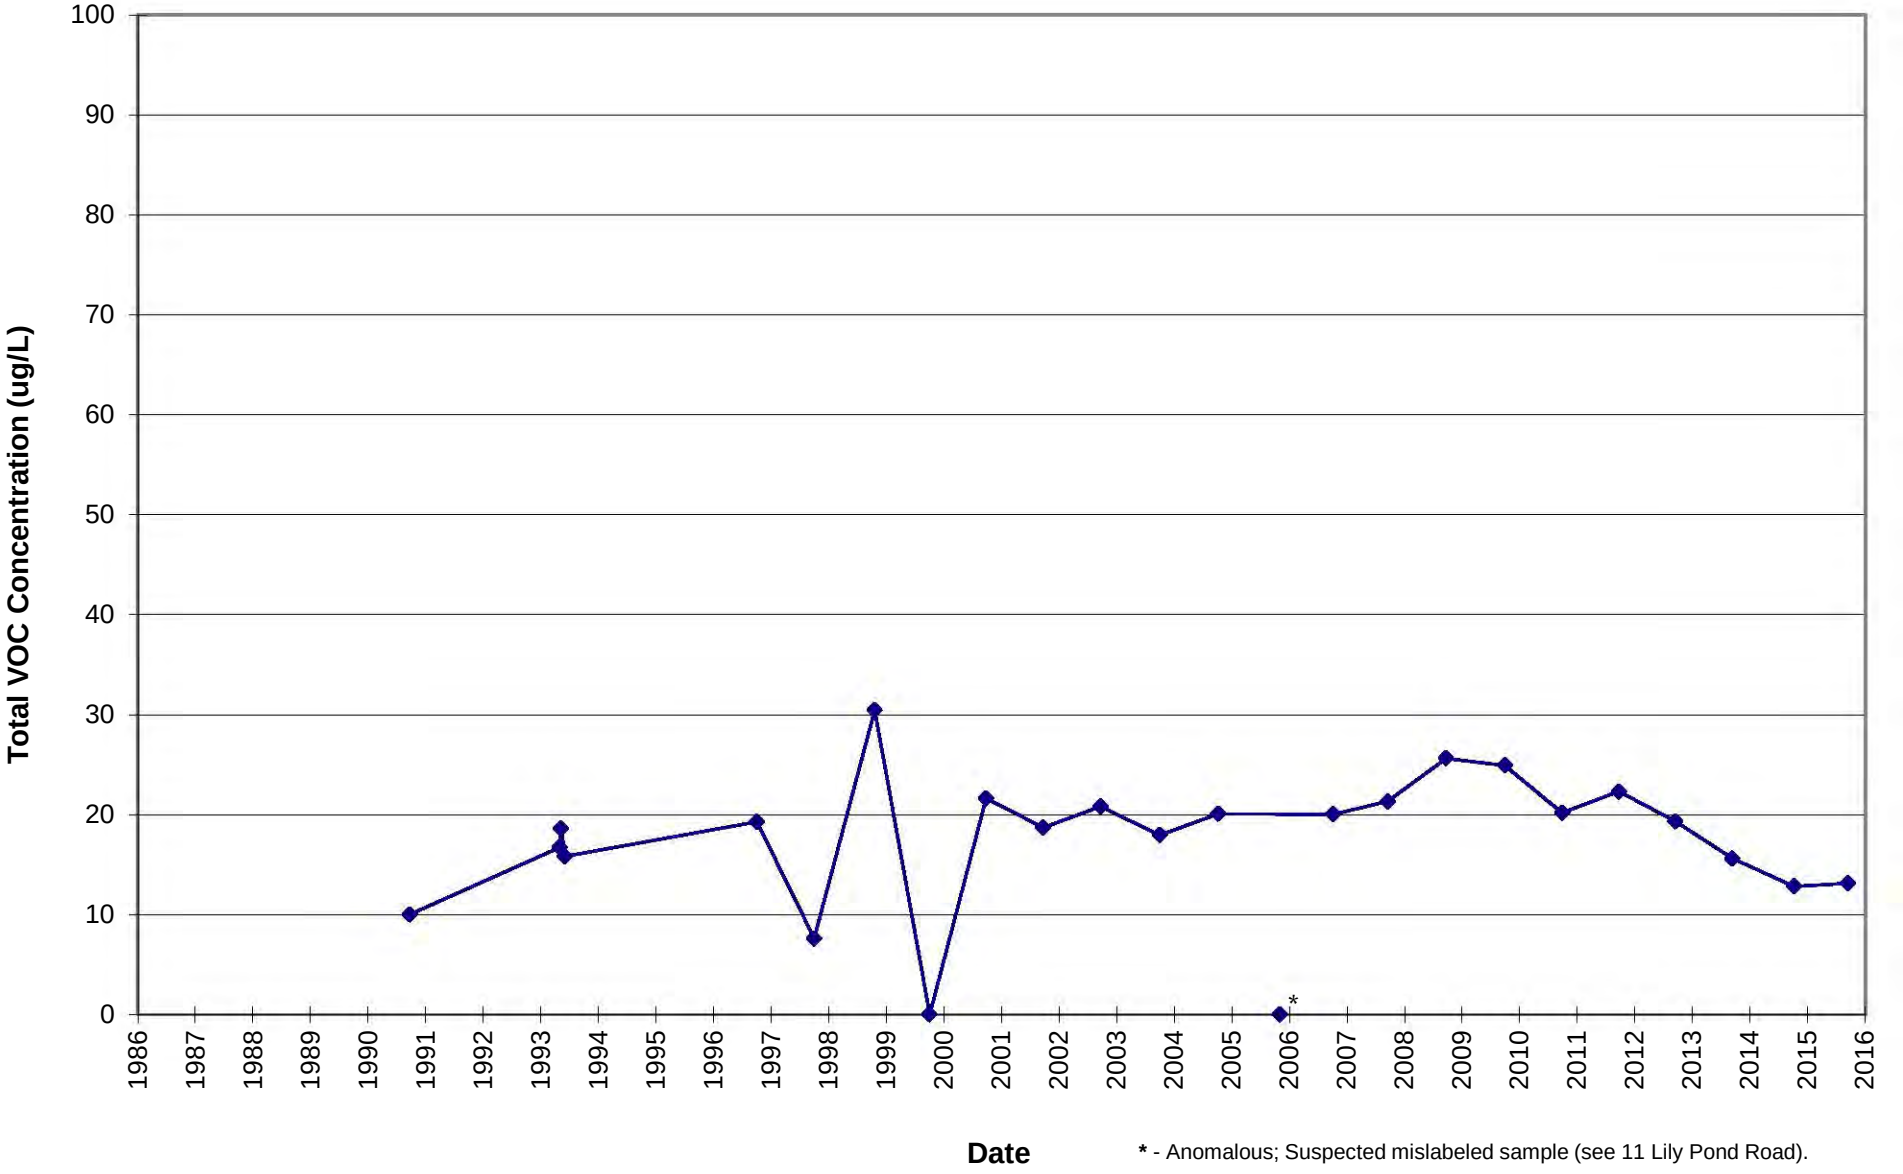
Figure 4.7

***** - Anomalous; Suspected mislabeled sample (see 11 Lily Pond Road).

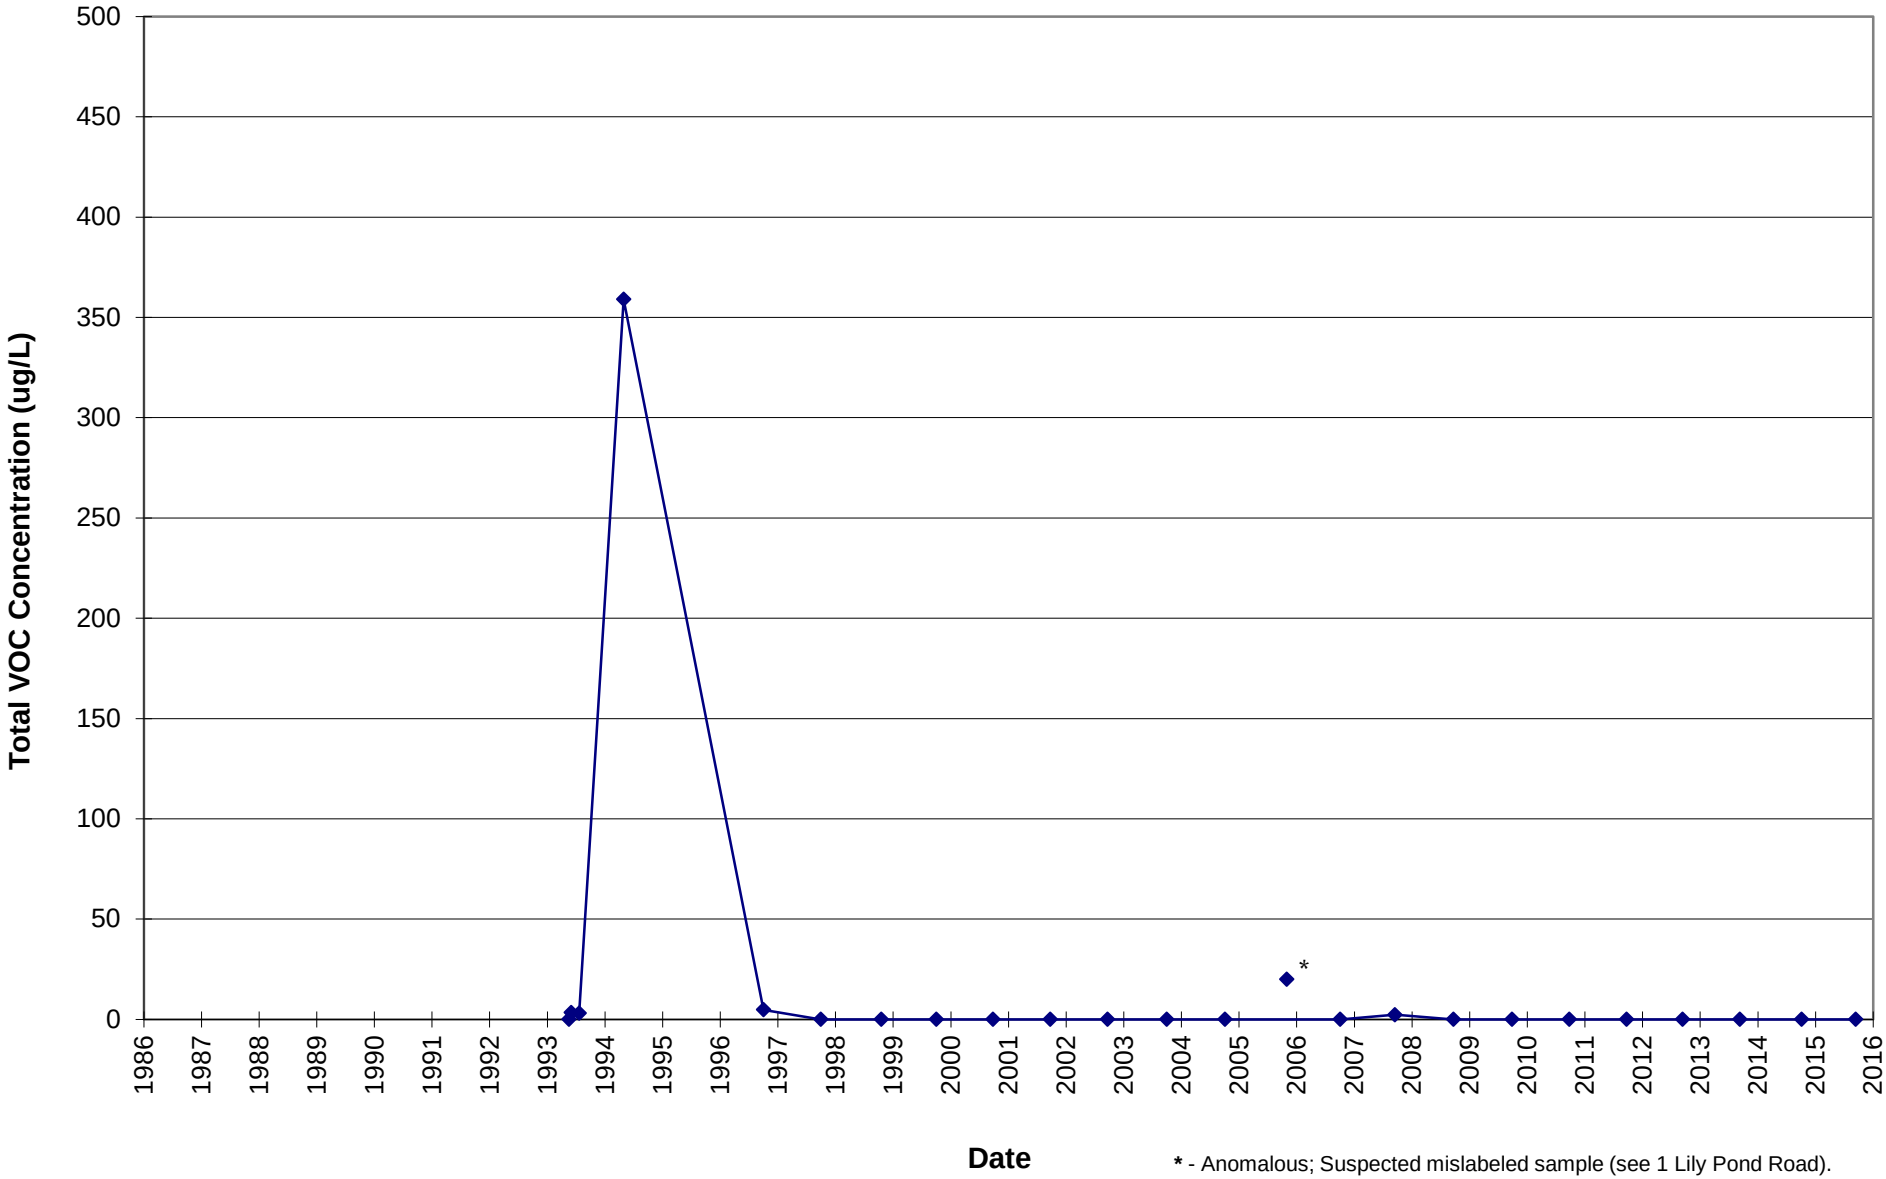
Figure 4.8

* - Anomalous; Suspected mislabeled sample (see 1 Lily Pond Road).

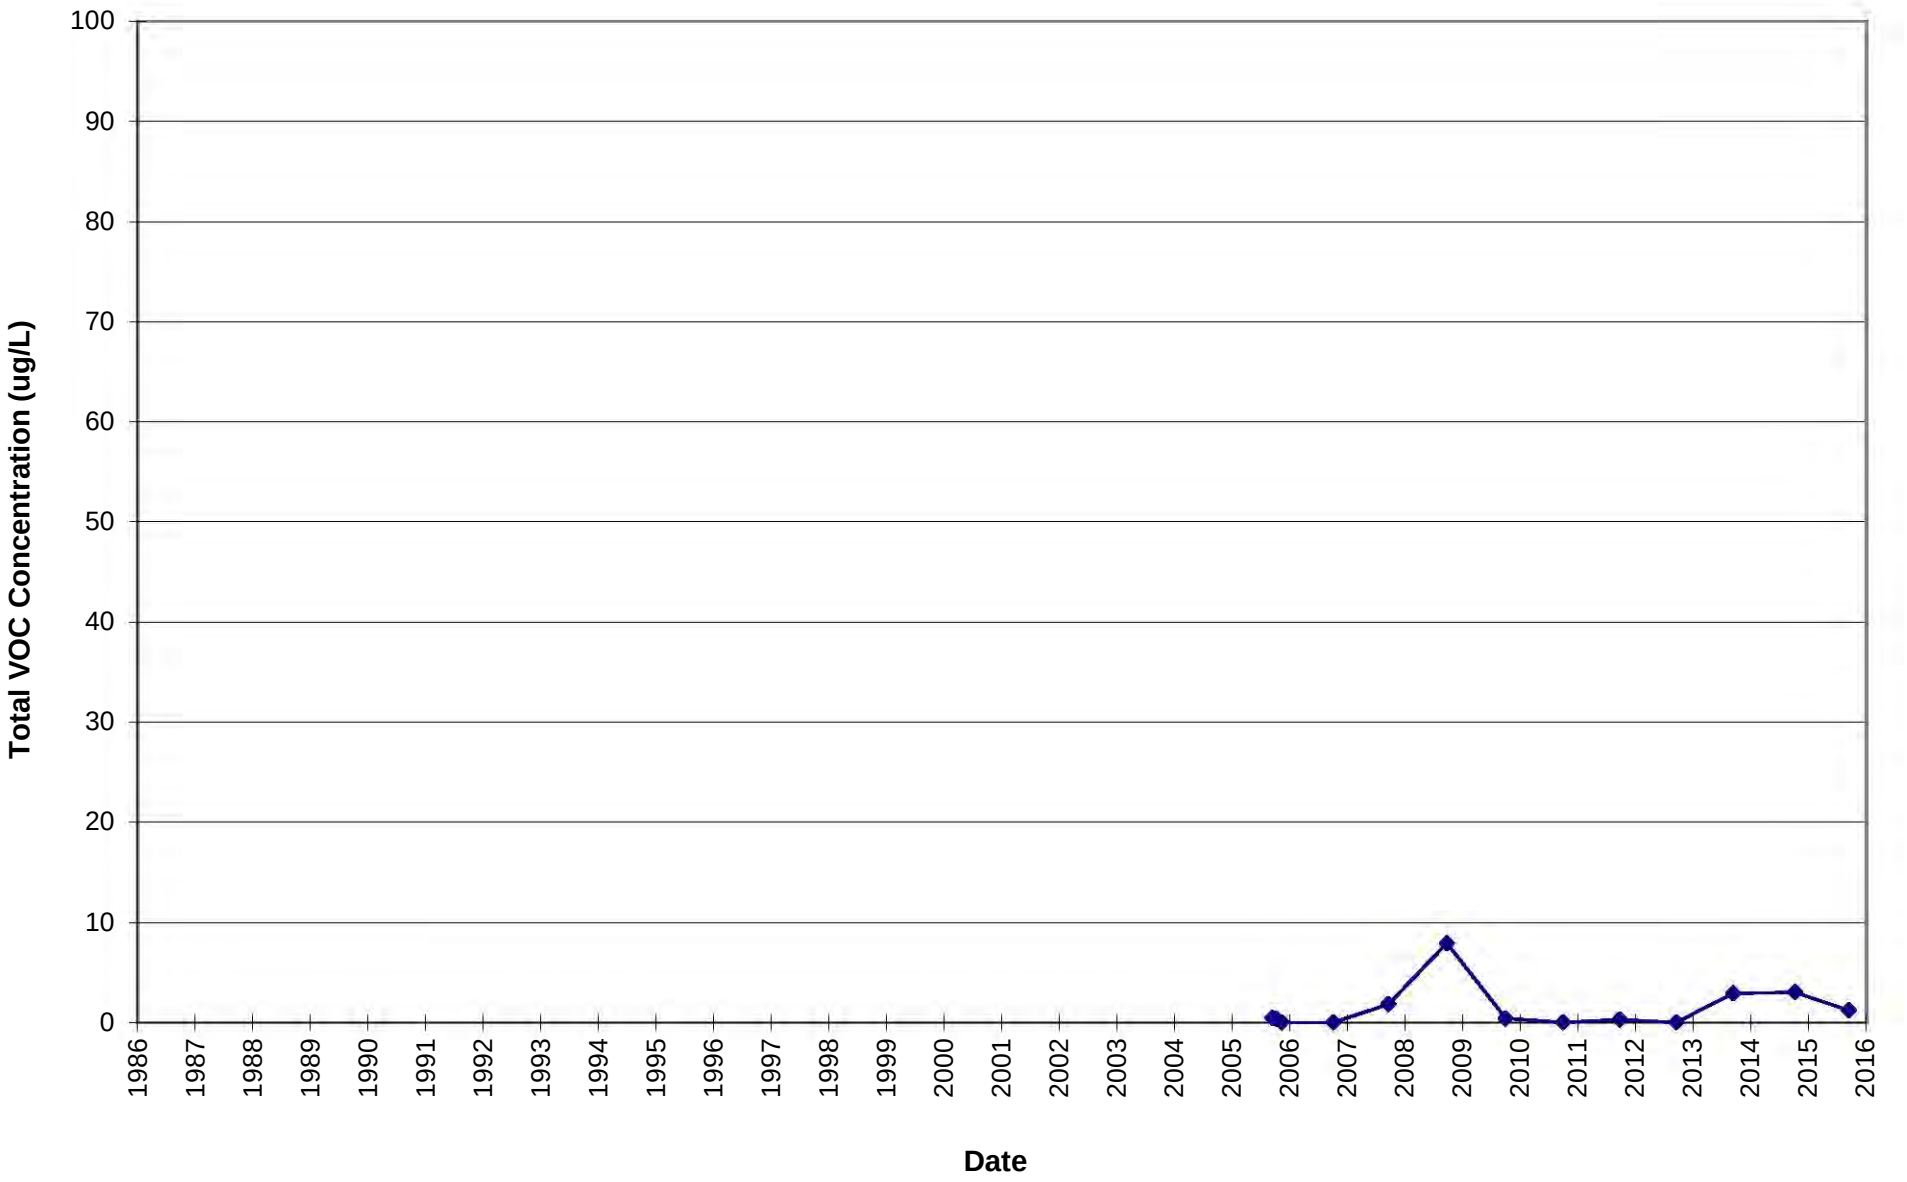
- Data from MW17L represent groundwater in the Prairie du Chien aquifer downgradient of the Highway 96 Site. Figure 4.10 illustrates that TVOC concentrations at MW17L have remained below 10 µg/L since sampling began at this location in 2005. In October 2015, the TVOC concentration at MW17L was 1.2 µg/L.

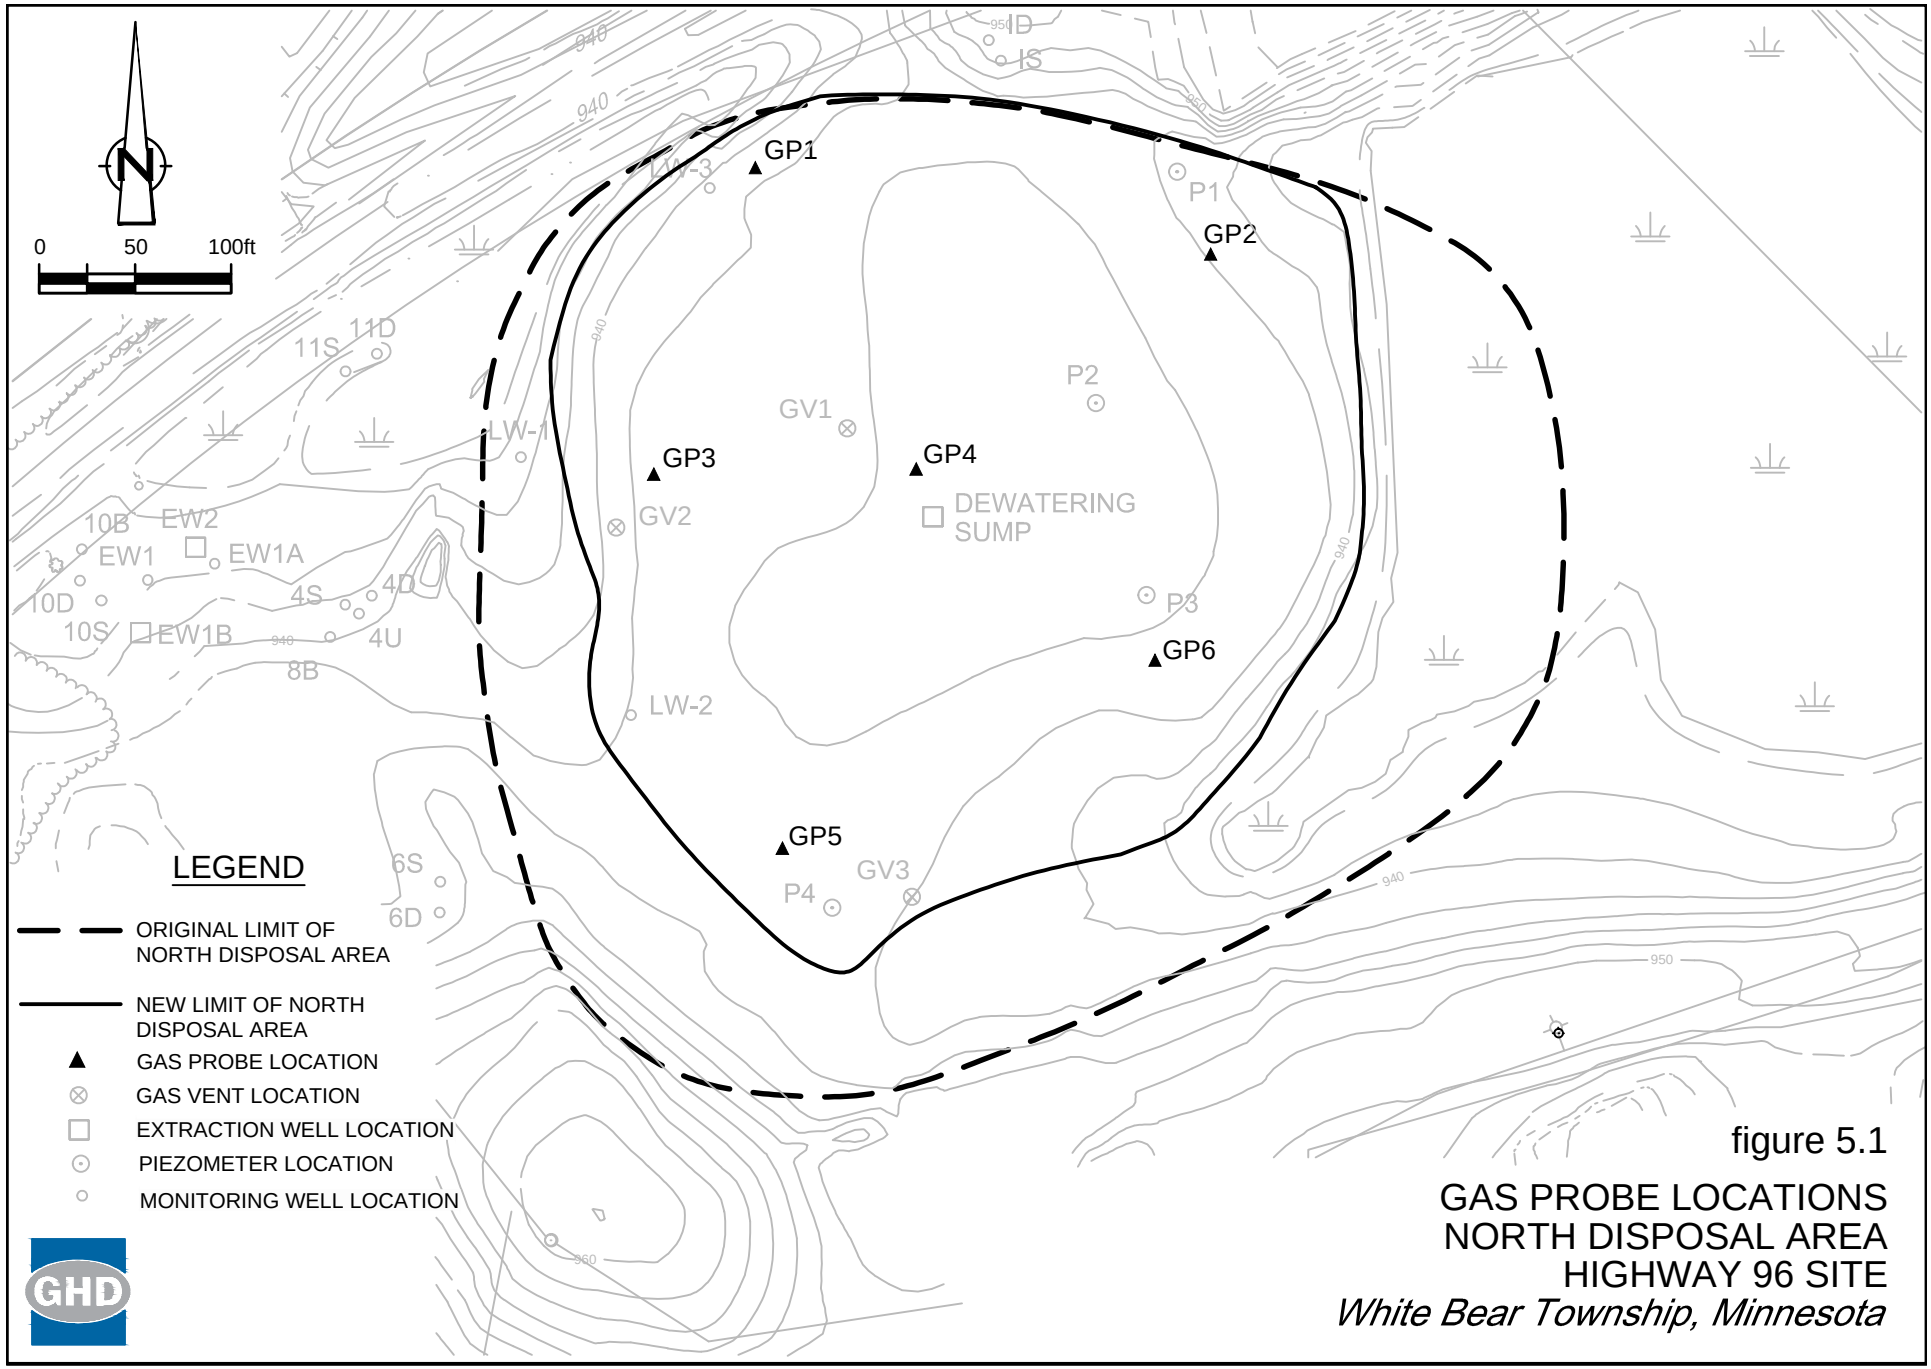
figure 5.1

The 2015 annual gas probe monitoring event was performed during the third quarter of 2015, to coincide with the annual soil cap inspection (see Section 6). During the third quarter of 2015, the six gas probe locations shown on Figure 5.1 were monitored for combustible gas using a LandTec GEM 500. Each gas probe was also monitored for positive pressure using the Land Tec meter (accurate to 0.1 inch of H_2O). The 2015 gas probe monitoring results are presented on Table 5.2.
