2015 Annual Monitoring Report

Highway 96 Site
White Bear Township, Minnesota

Highway 96 Group

1801 Old Highway 8 Northwest Suite 114 St. Paul Minnesota 55112
002012 | Report No 66 | March 14 2016

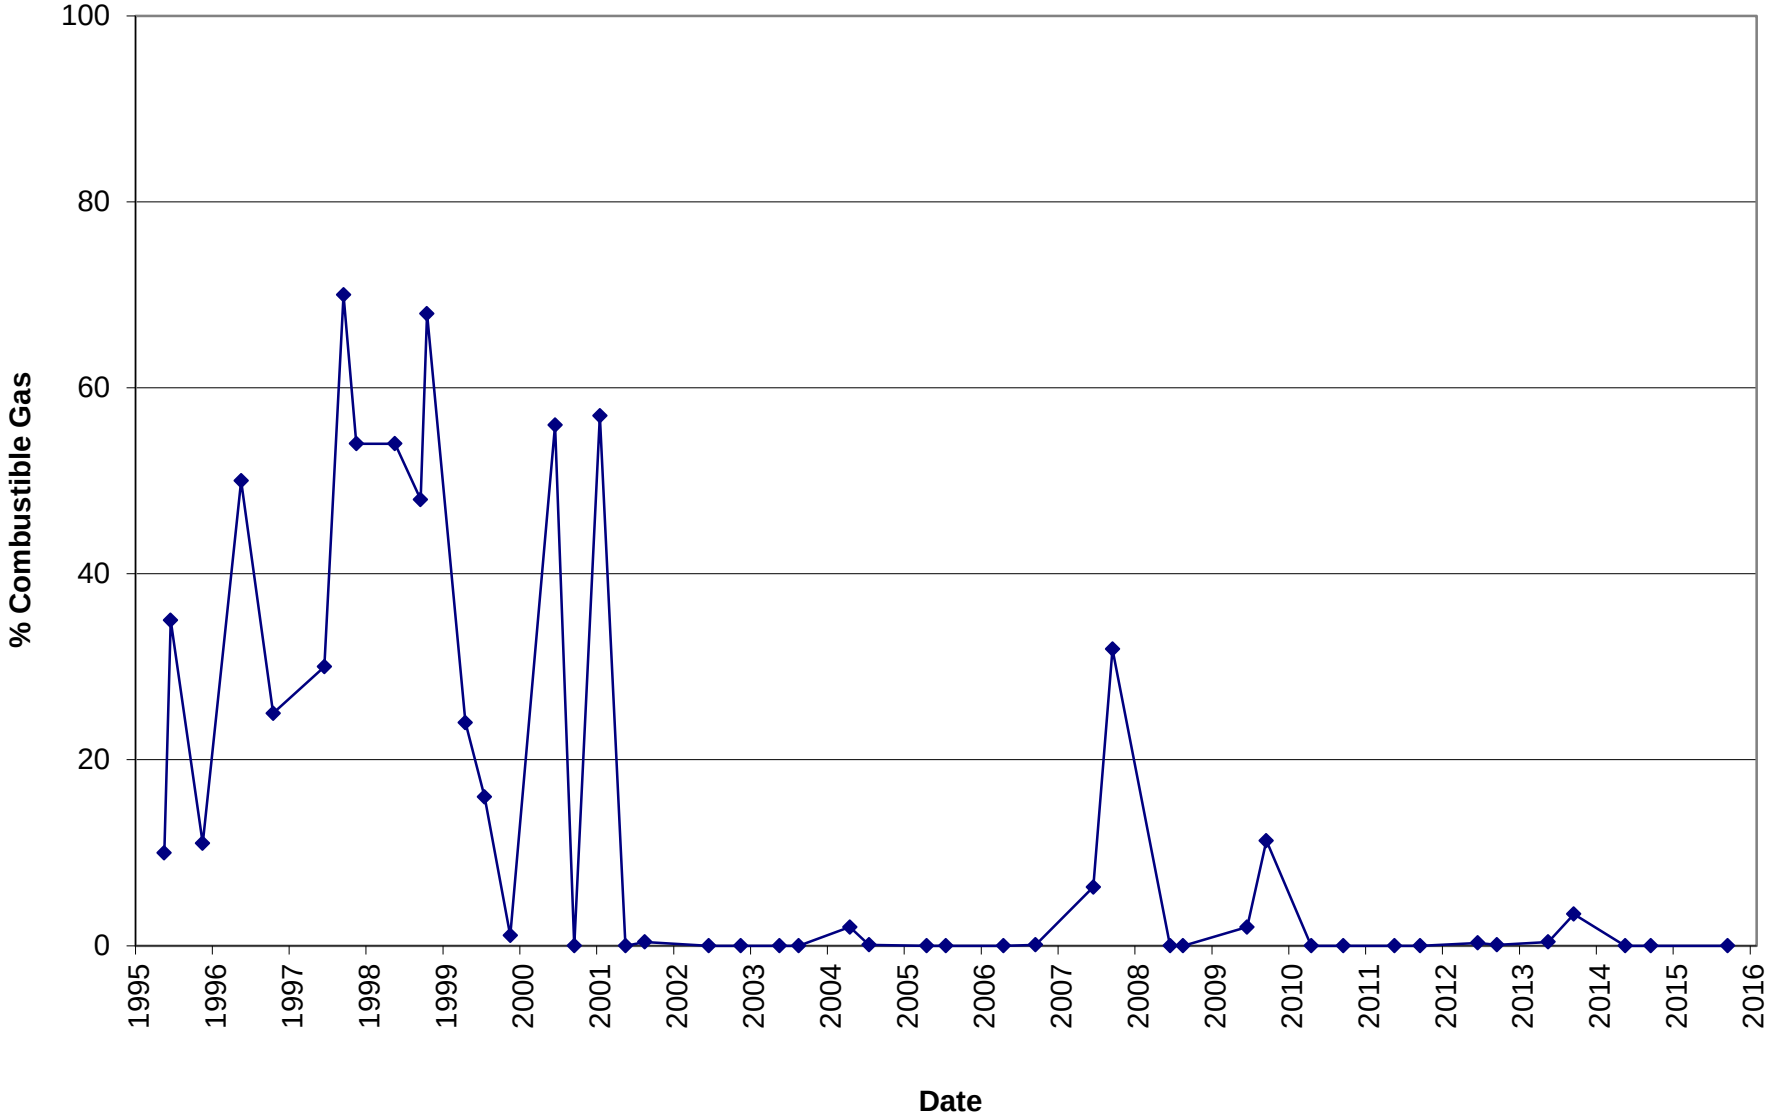
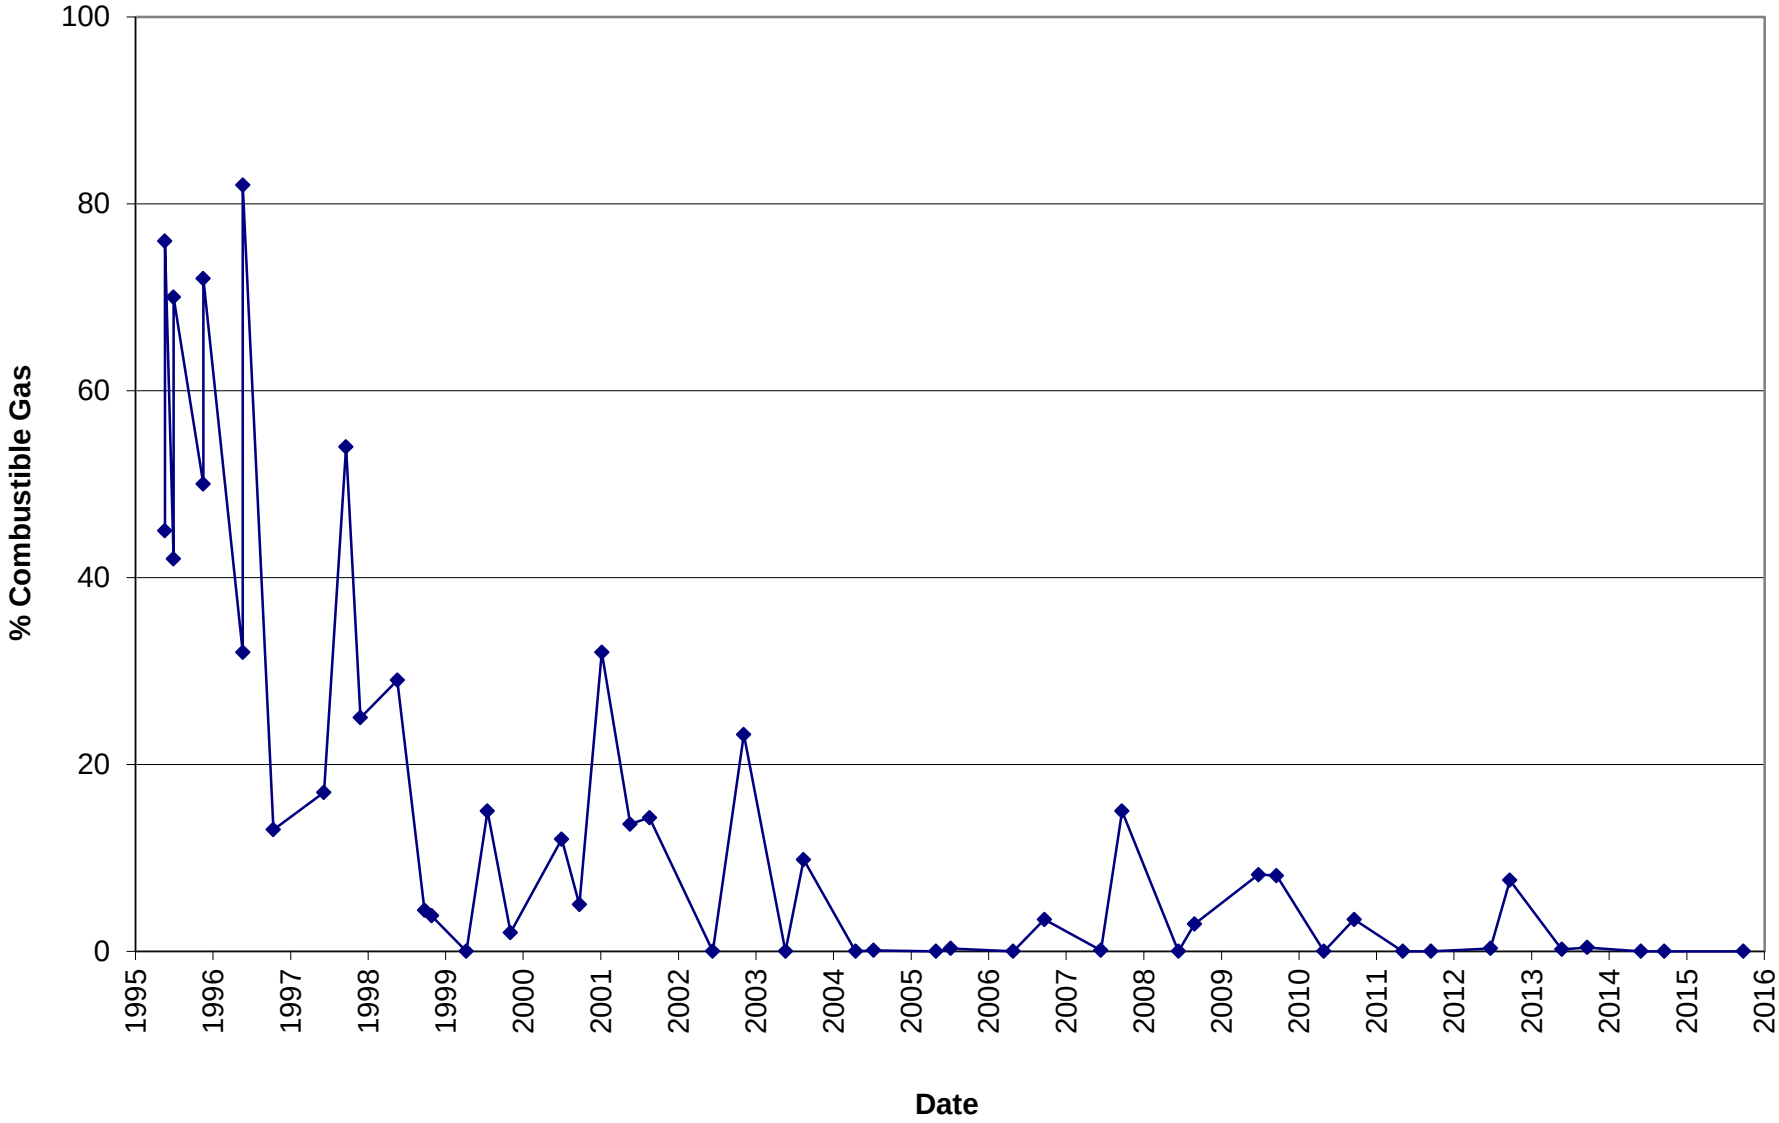
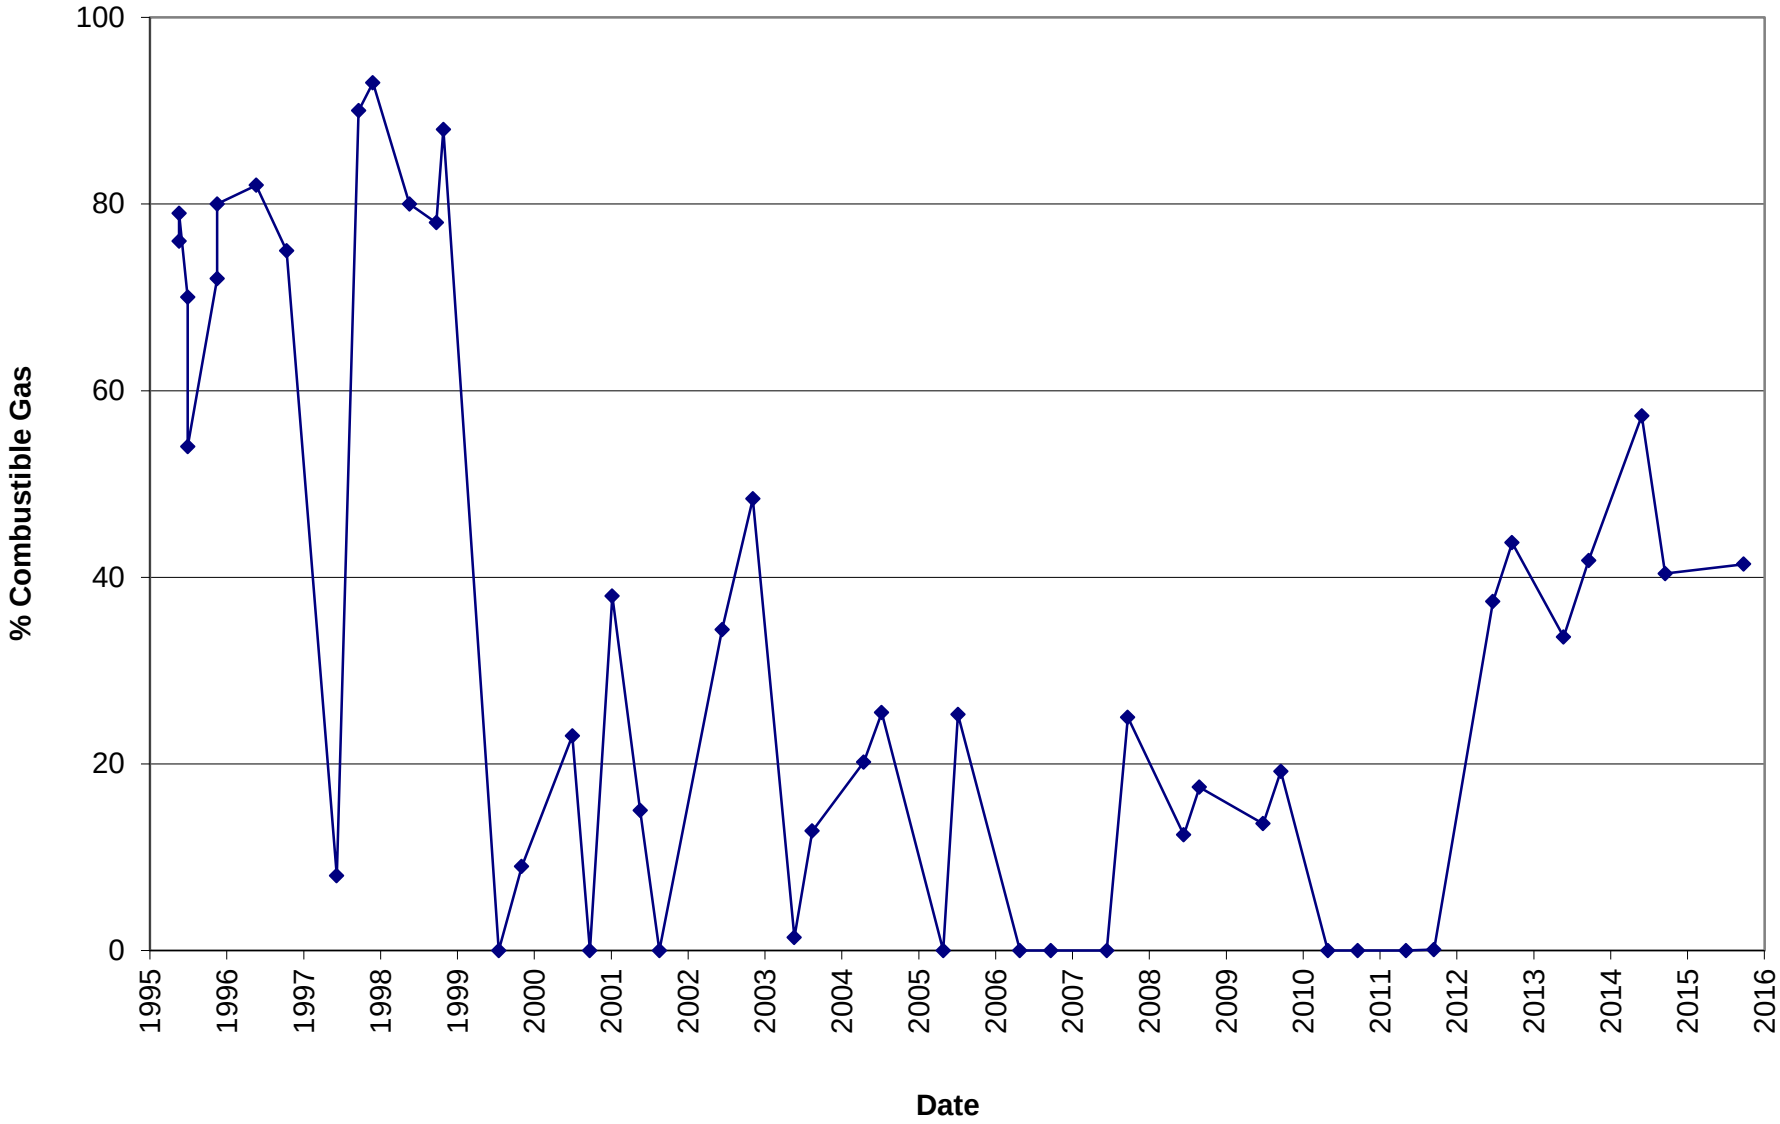
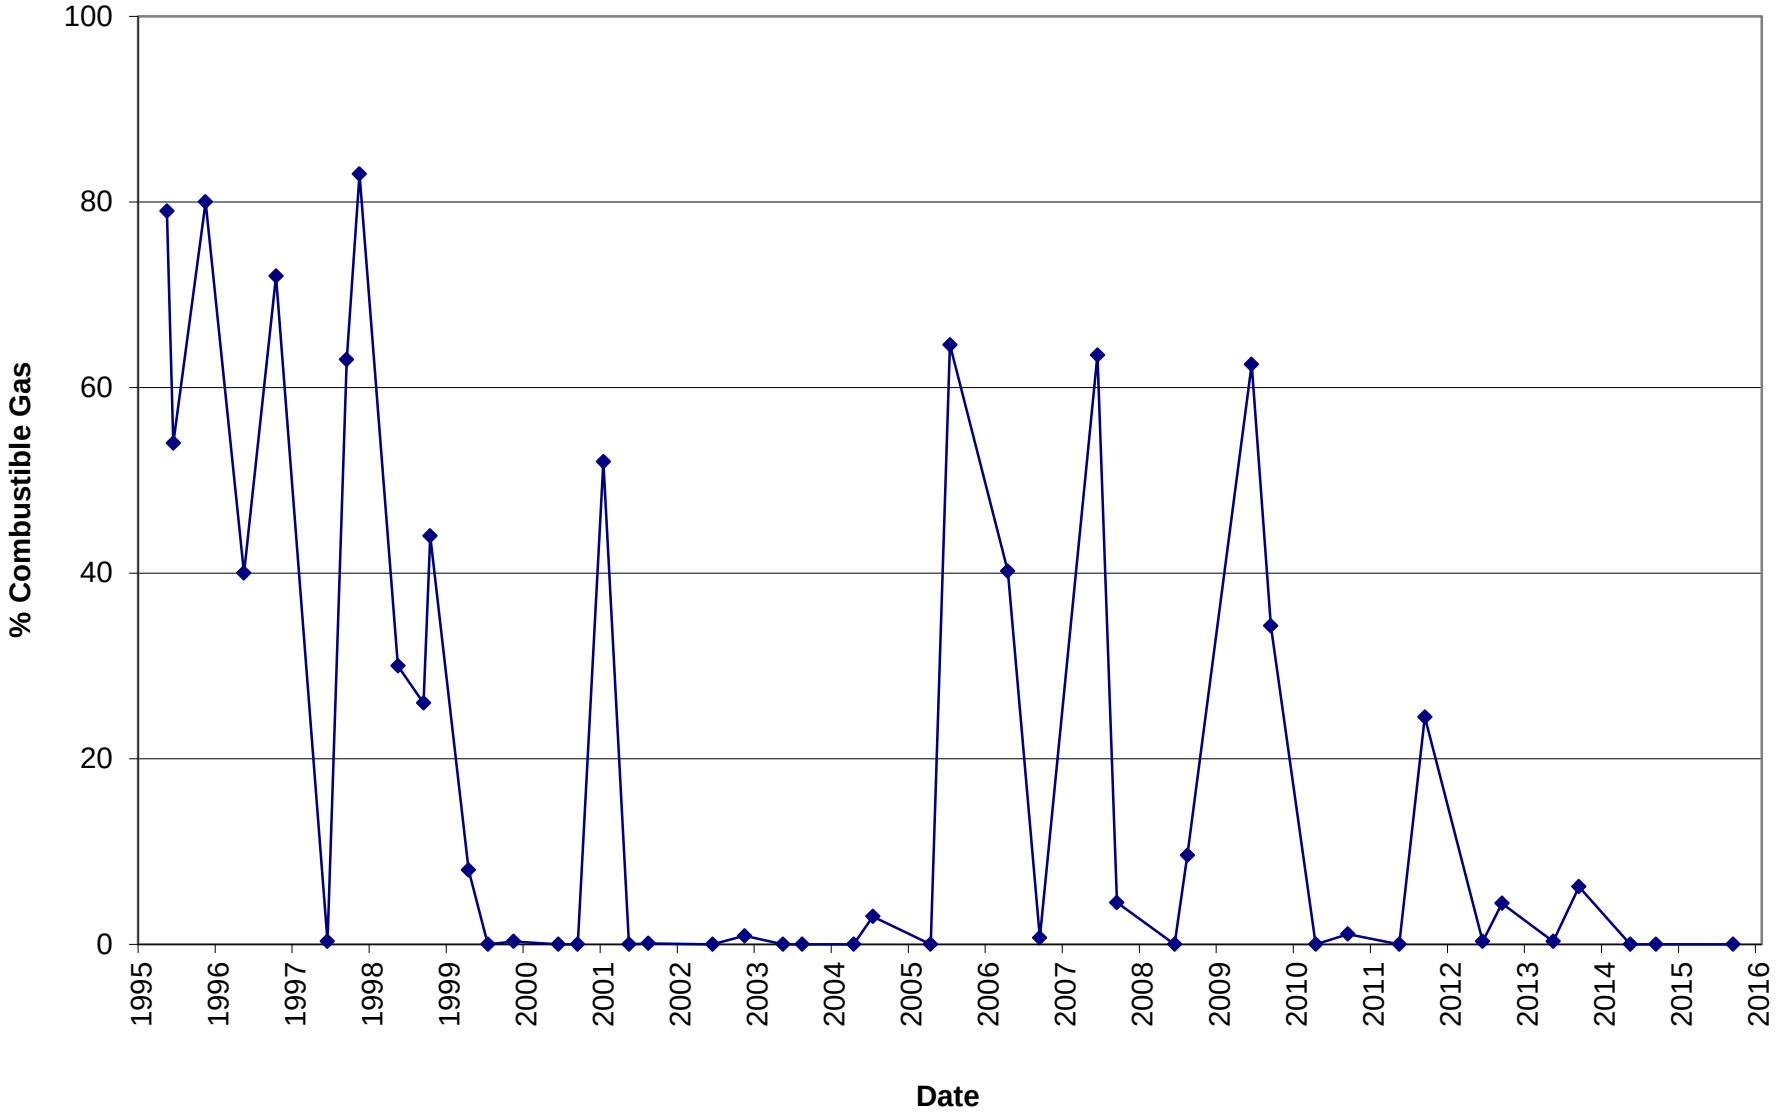
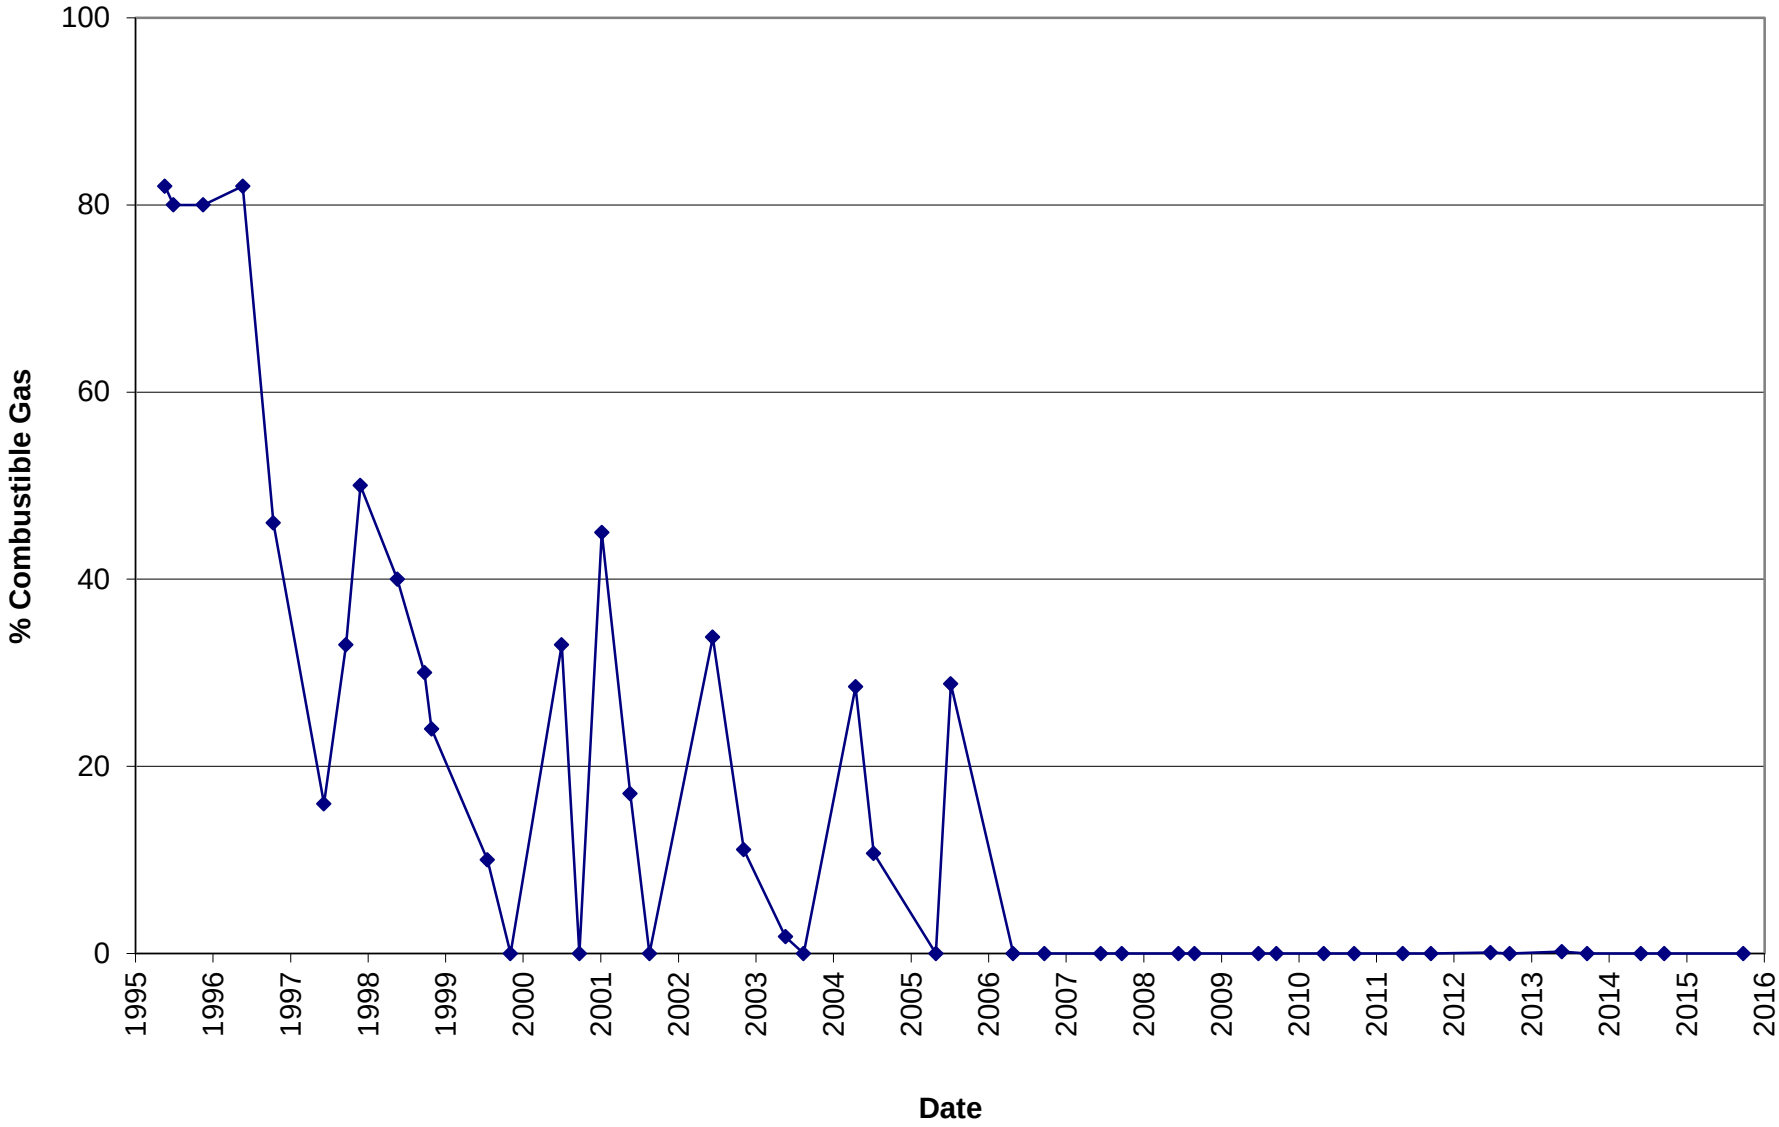
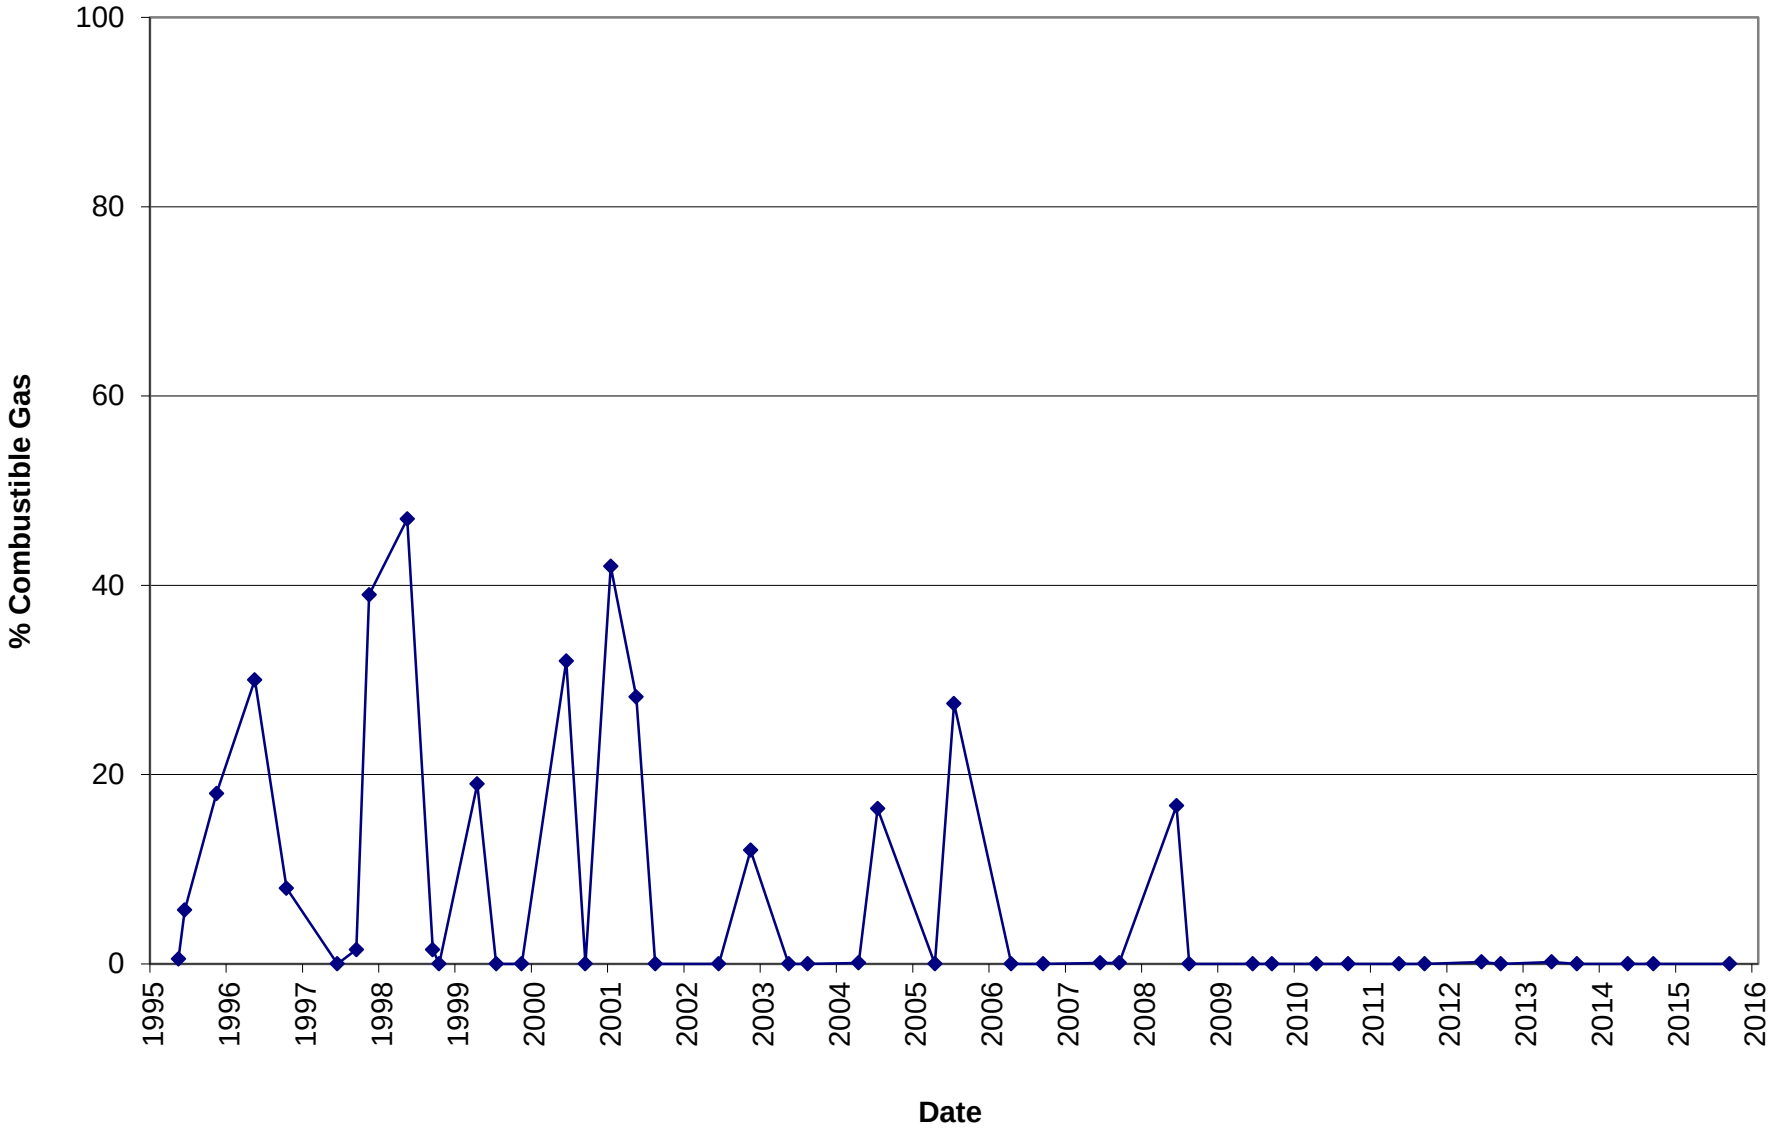
Figures 5.2 through 5.7 show the percent combustible gas vs. time graphs for GP1 through GP6, respectively. Since combustible gas monitoring began at the Site, no clear Site-wide trend has emerged.
